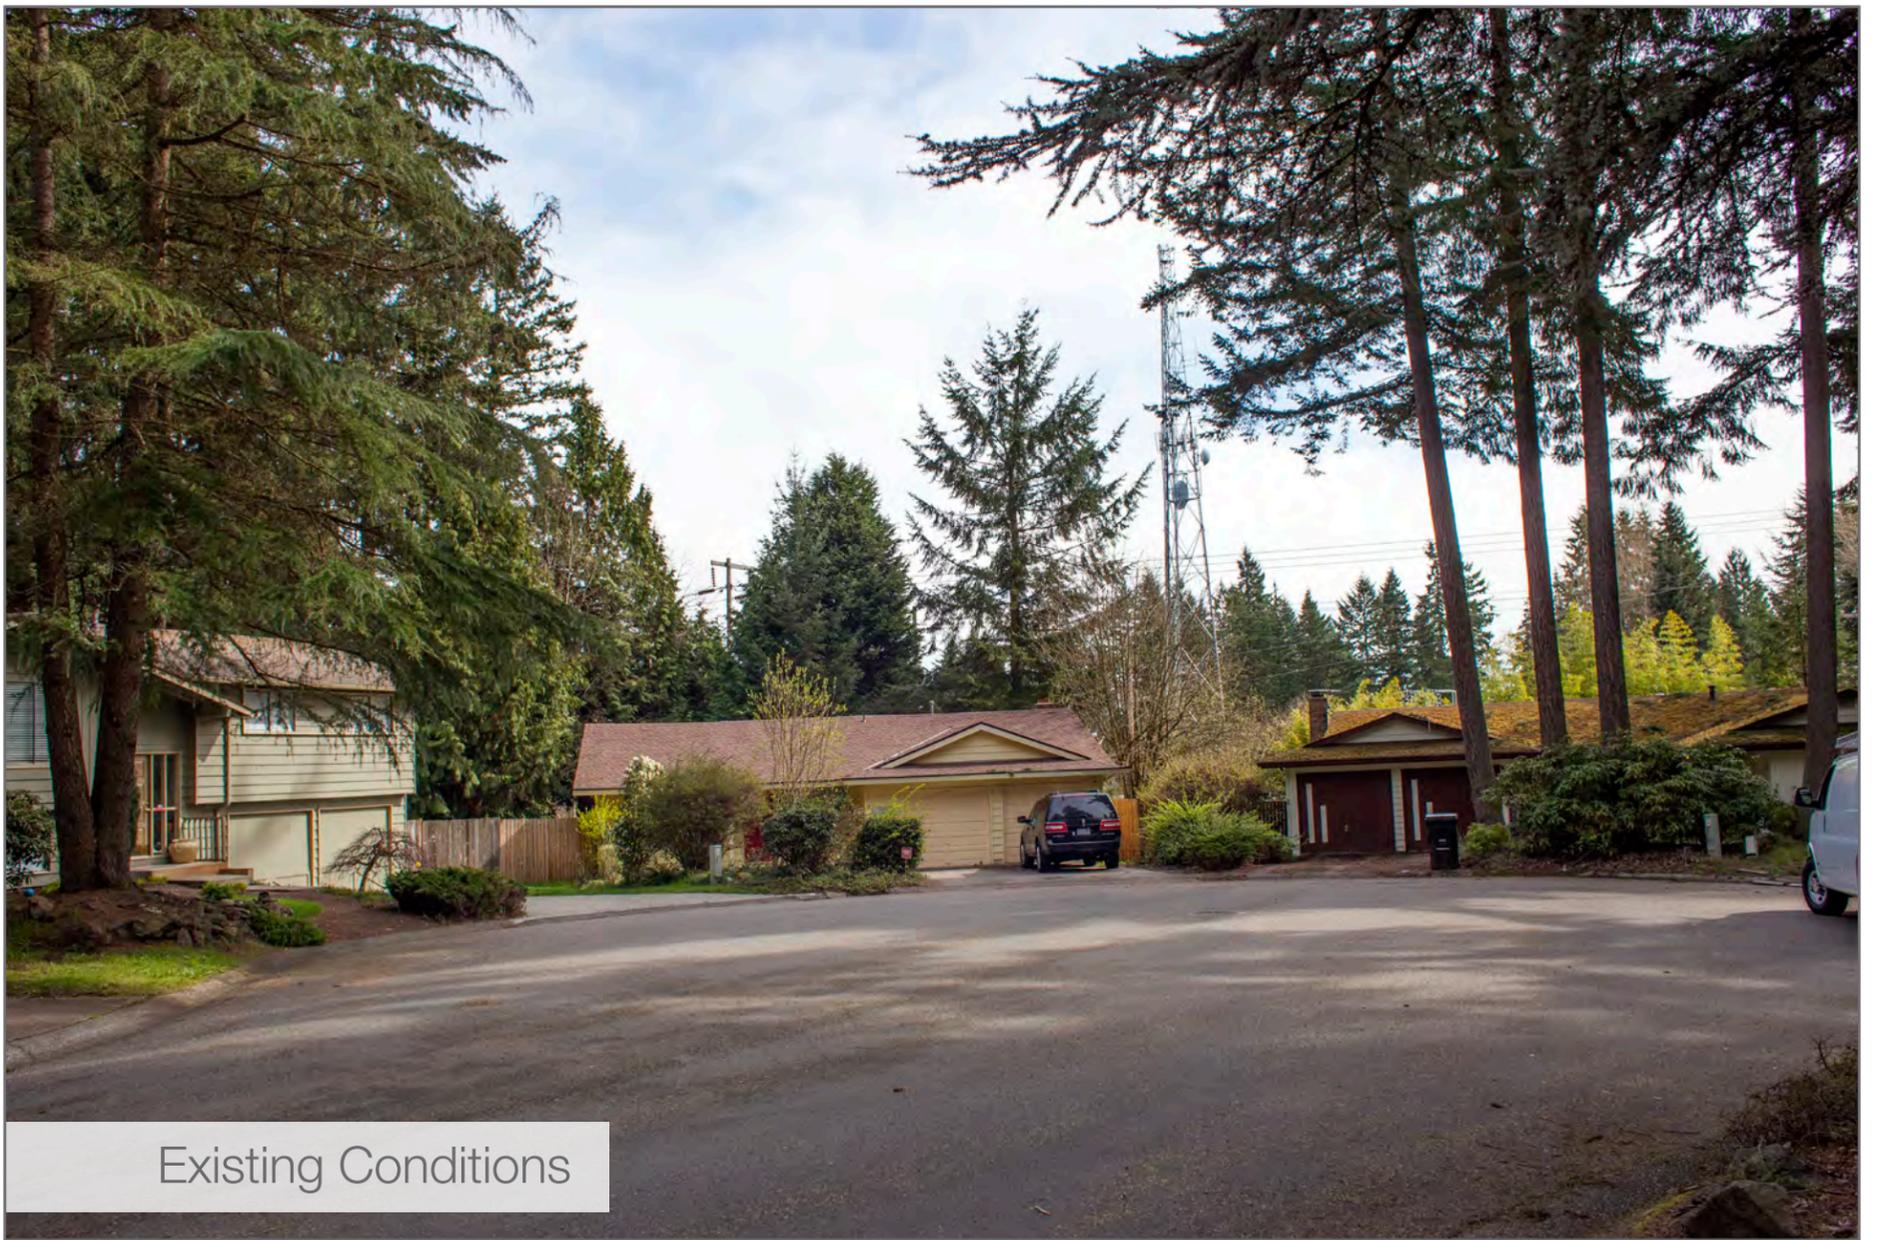
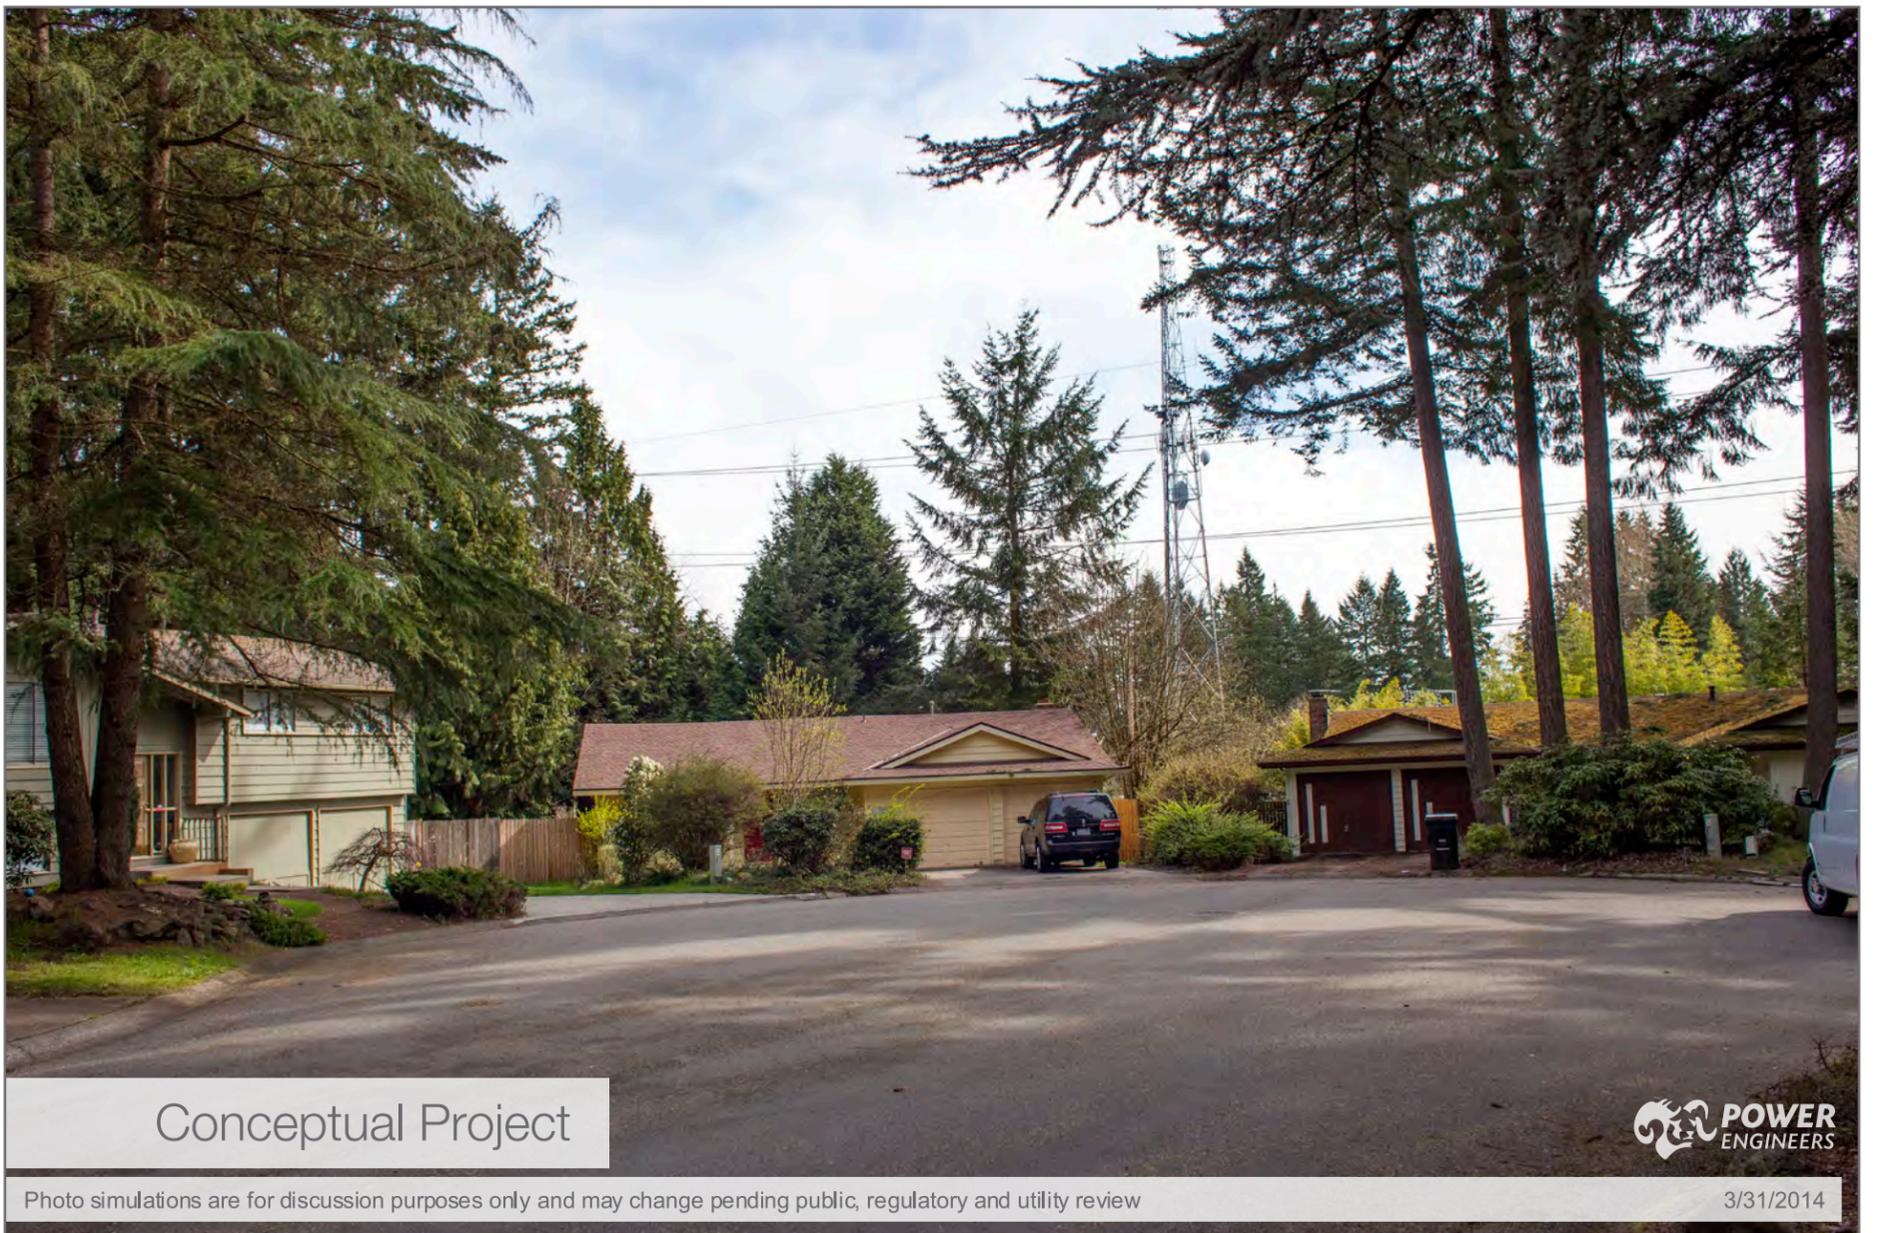
KOP NORTH 1 SEGMENT C

Address	13615 NE 78th PI
Date	3/31/2014
Time	11:20 AM
Viewing Direction	West
Structure	G2-1

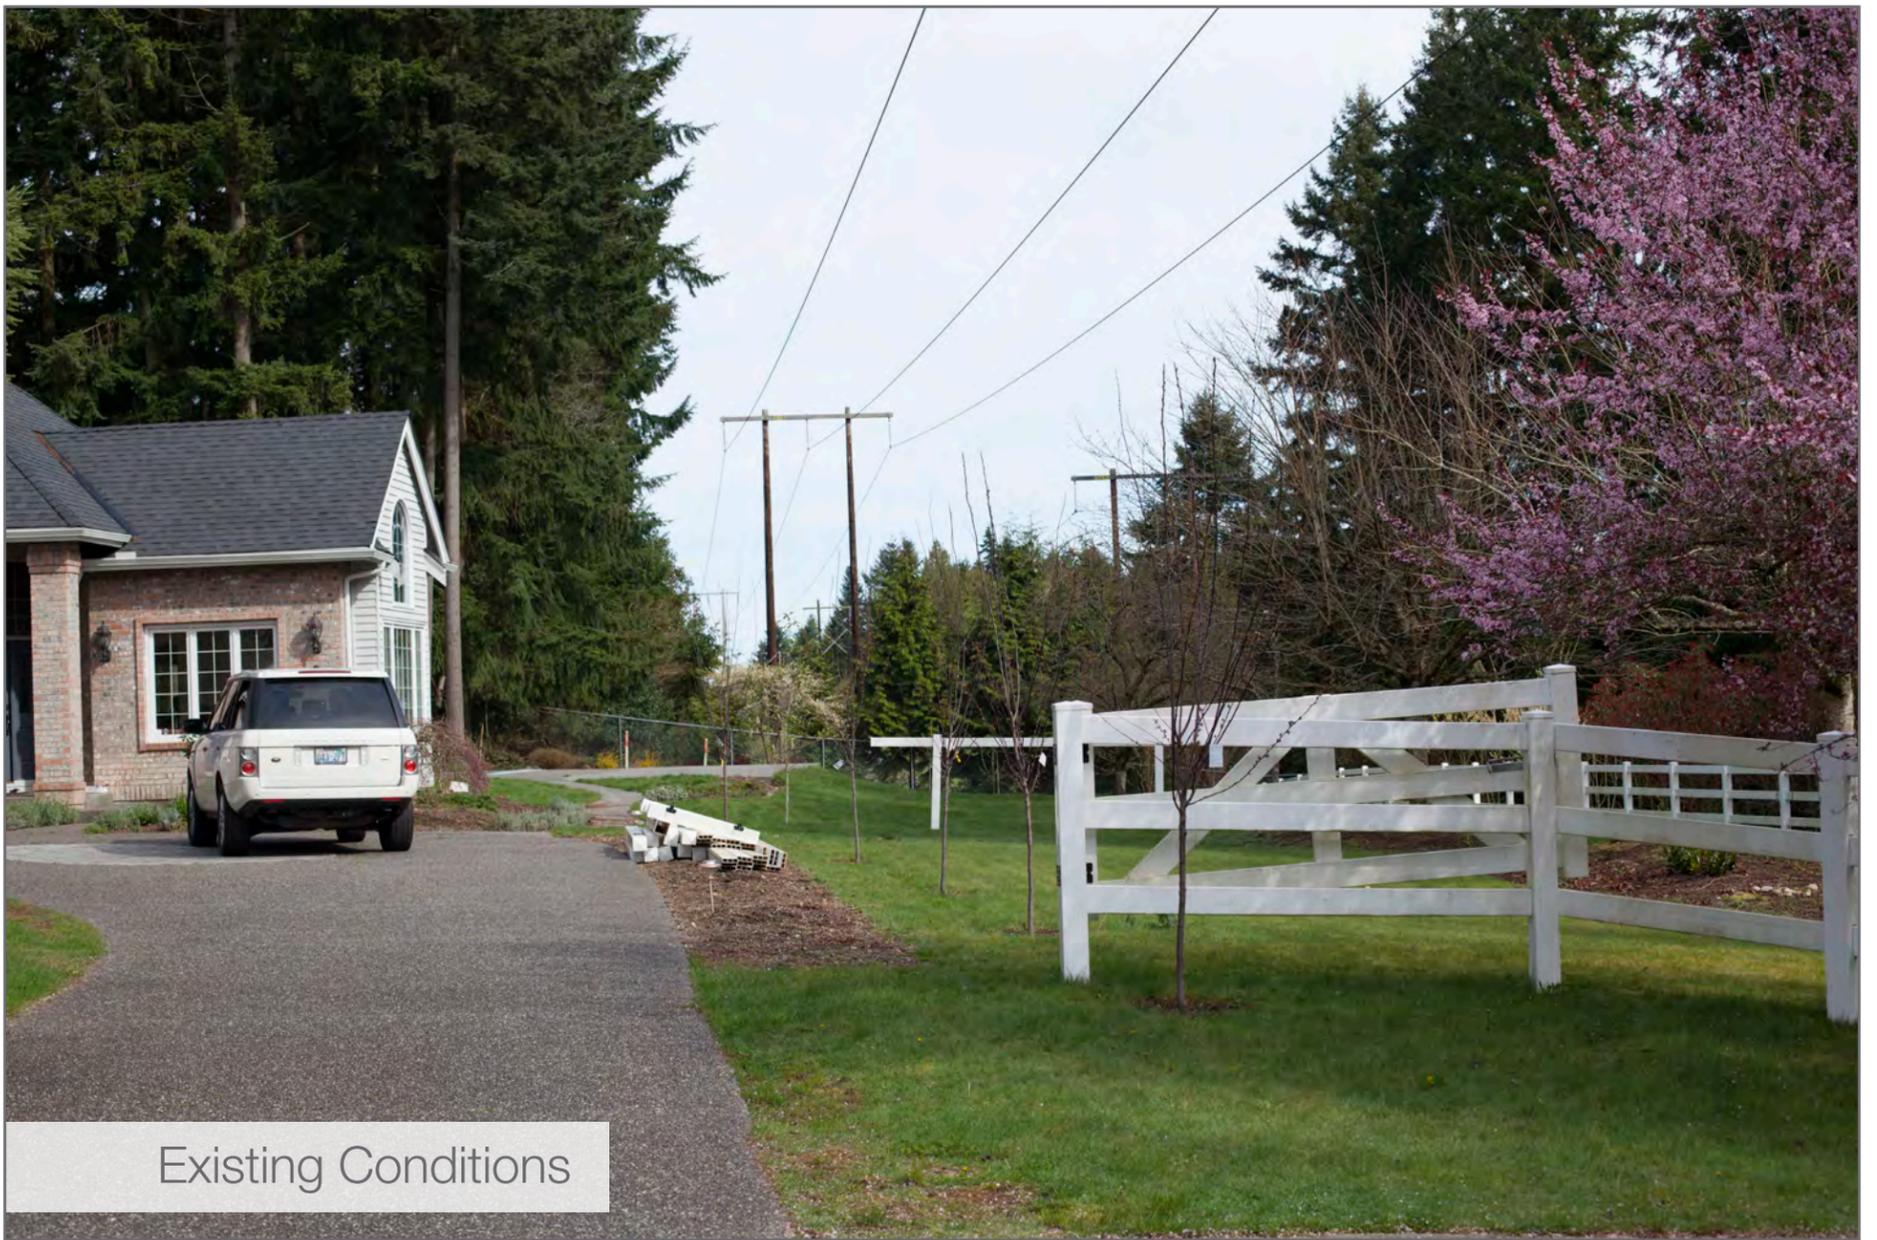
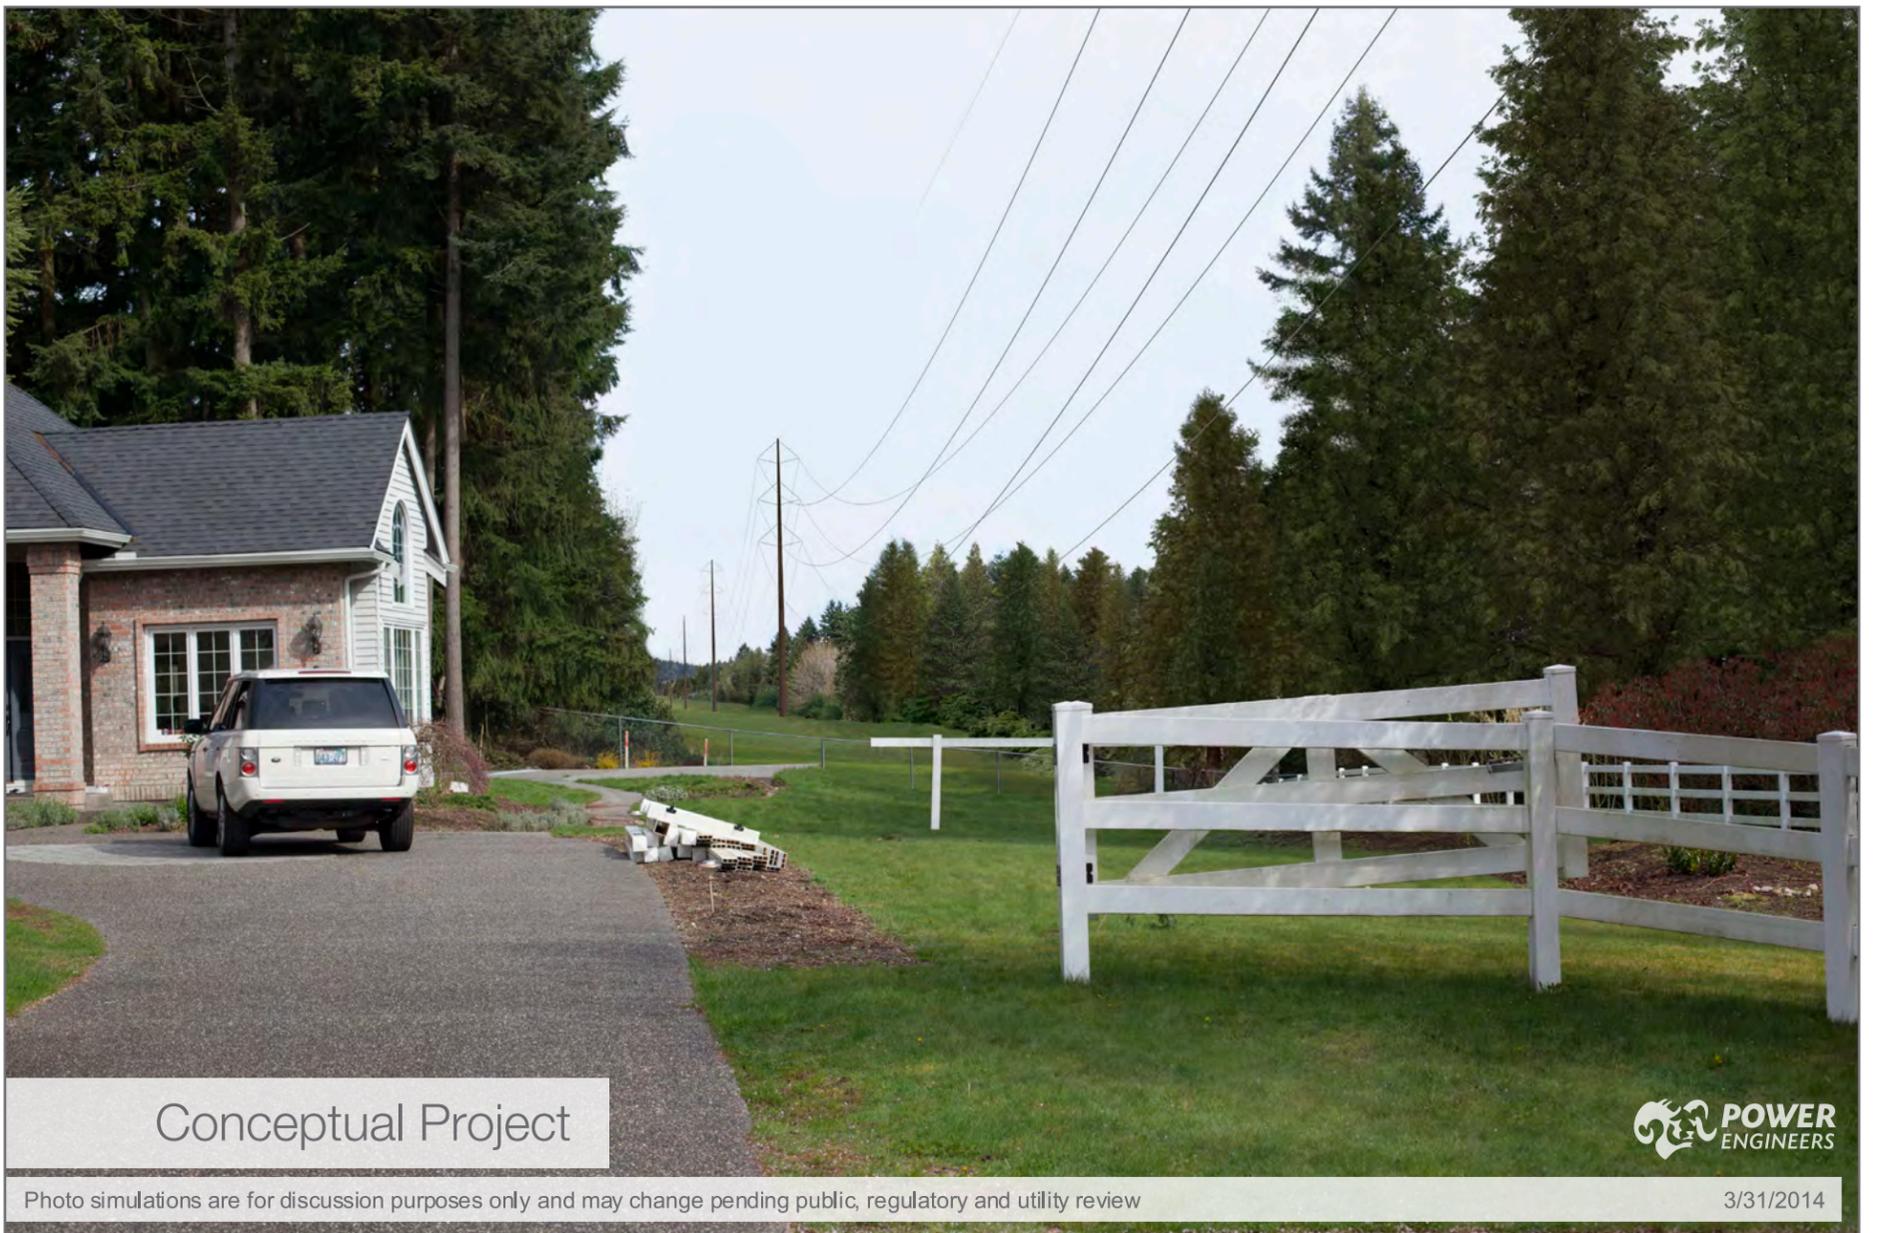
KOP NORTH 3 SEGMENT C

Address	13538 NE 54th PI
Date	3/31/2014
Time	10:49 AM
Viewing Direction	North
Structure	G2-5

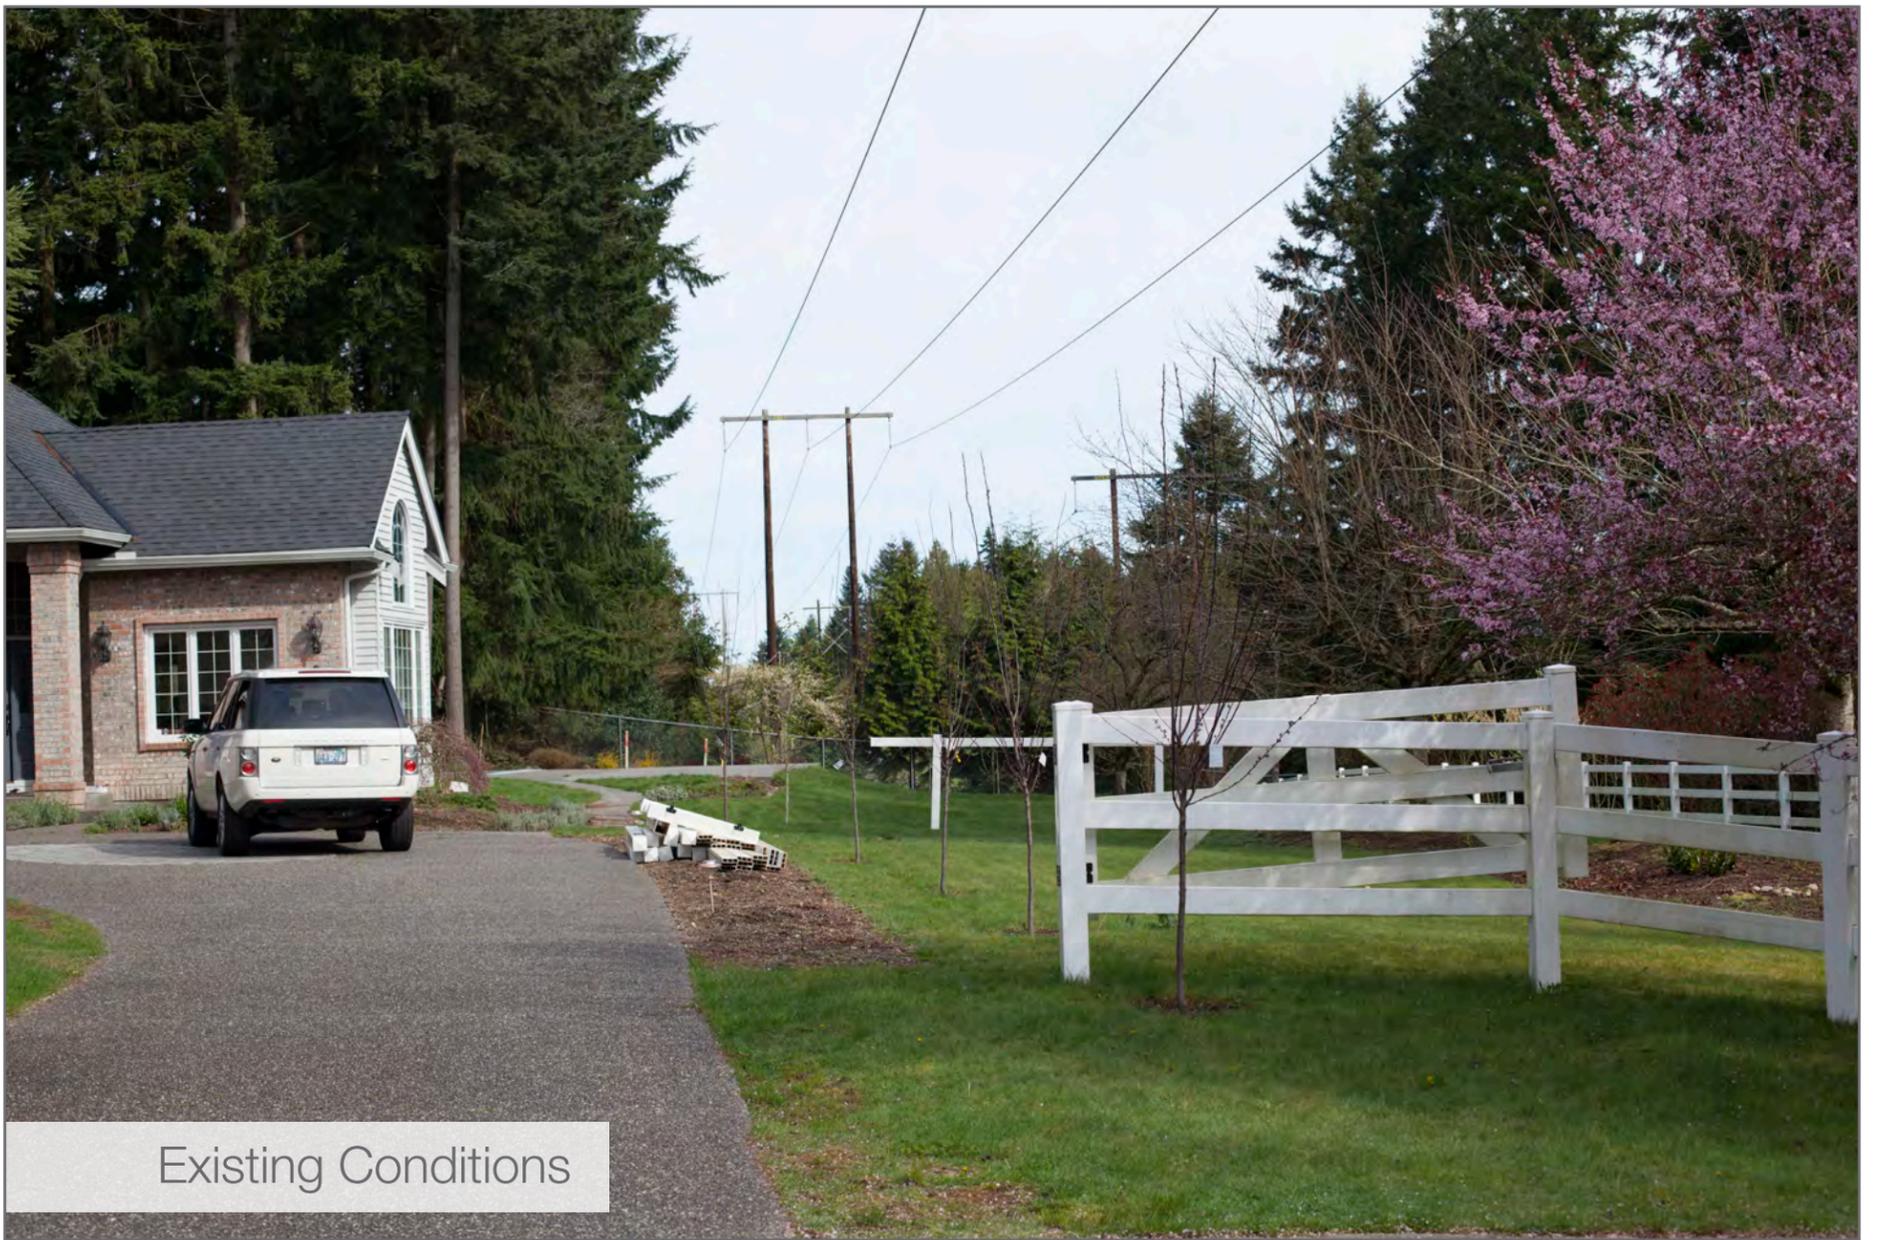
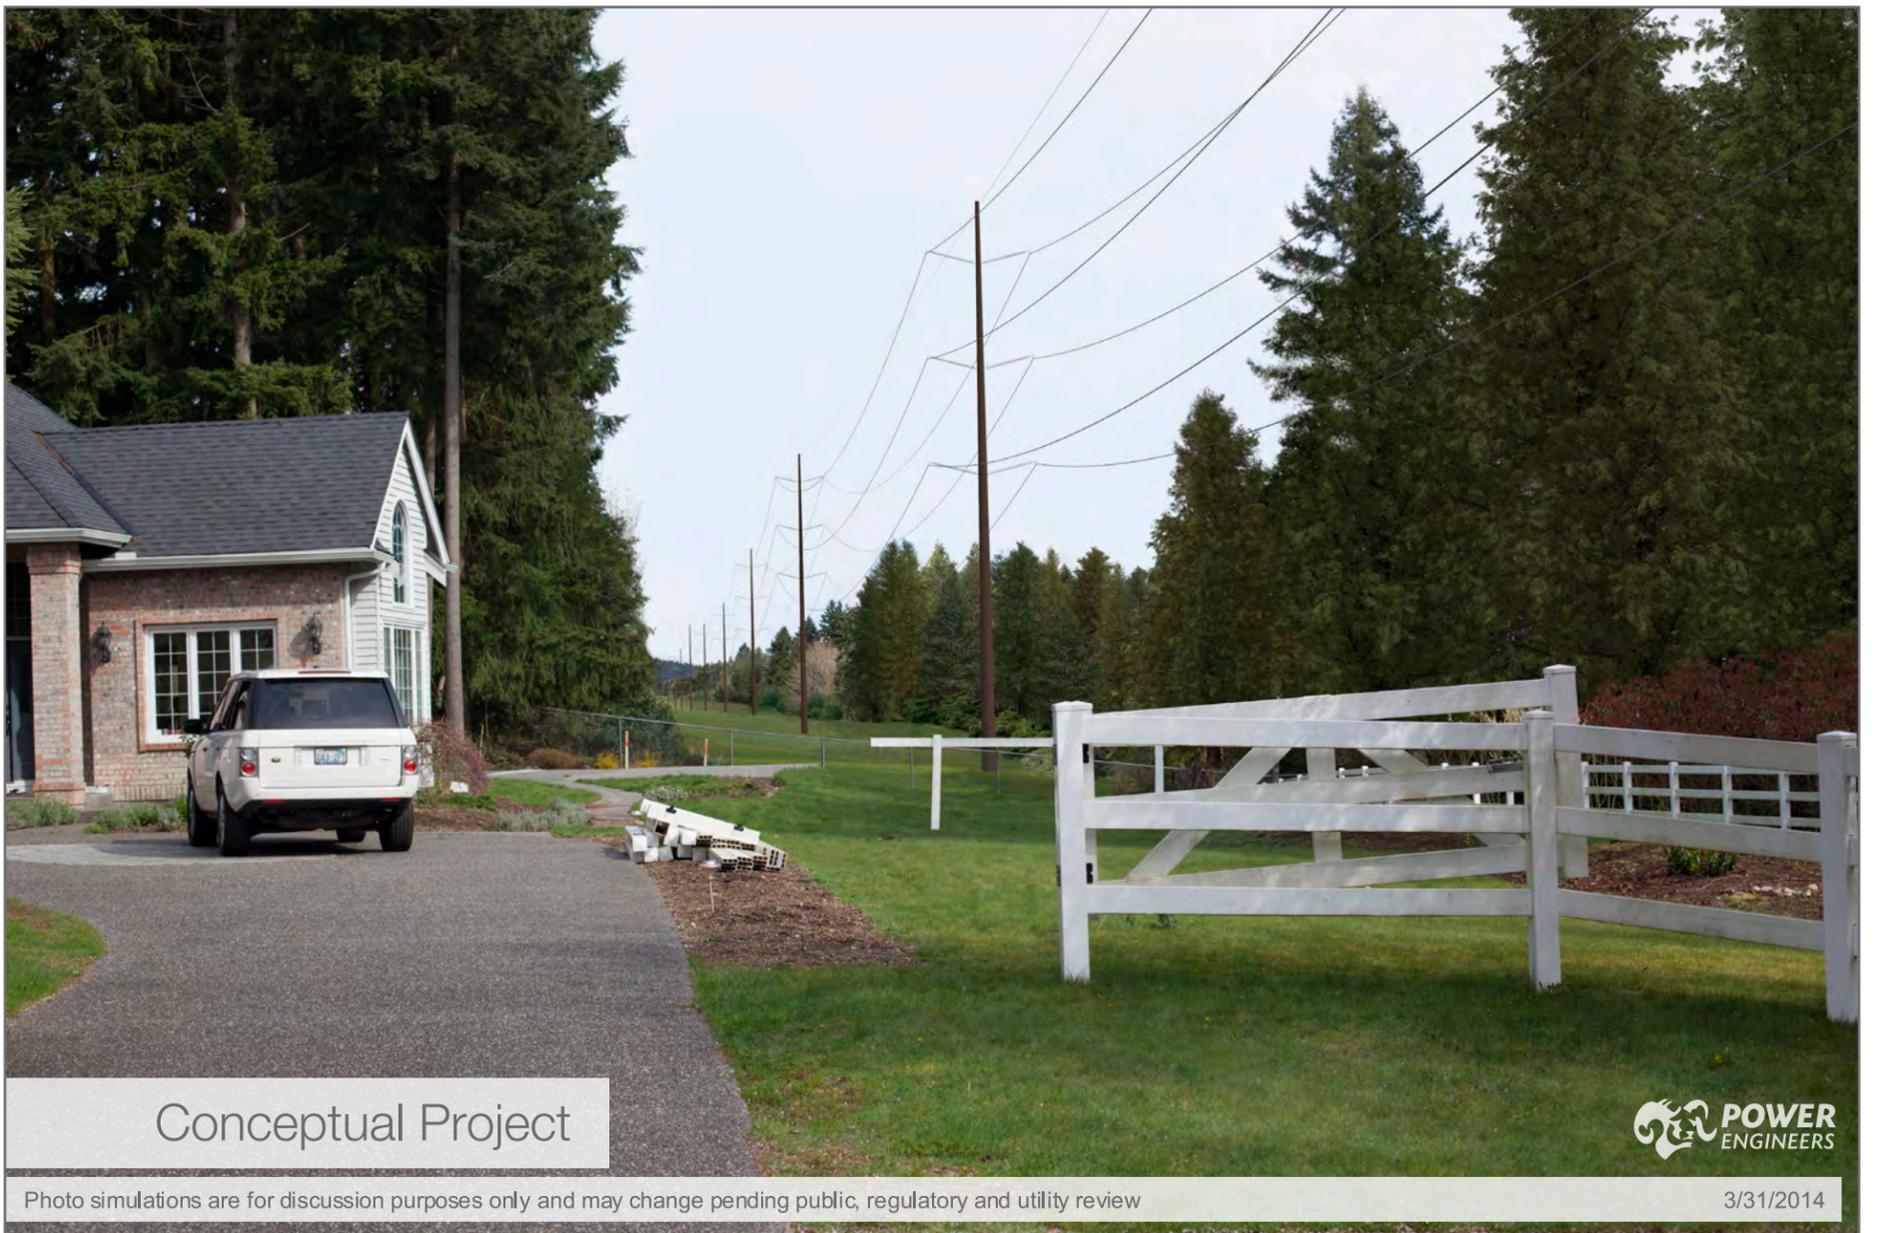
KOP NORTH 3 SEGMENT C

Address	13538 NE 54th PI
Date	3/31/2014
Time	10:49 AM
Viewing Direction	North
Structure	G2-6

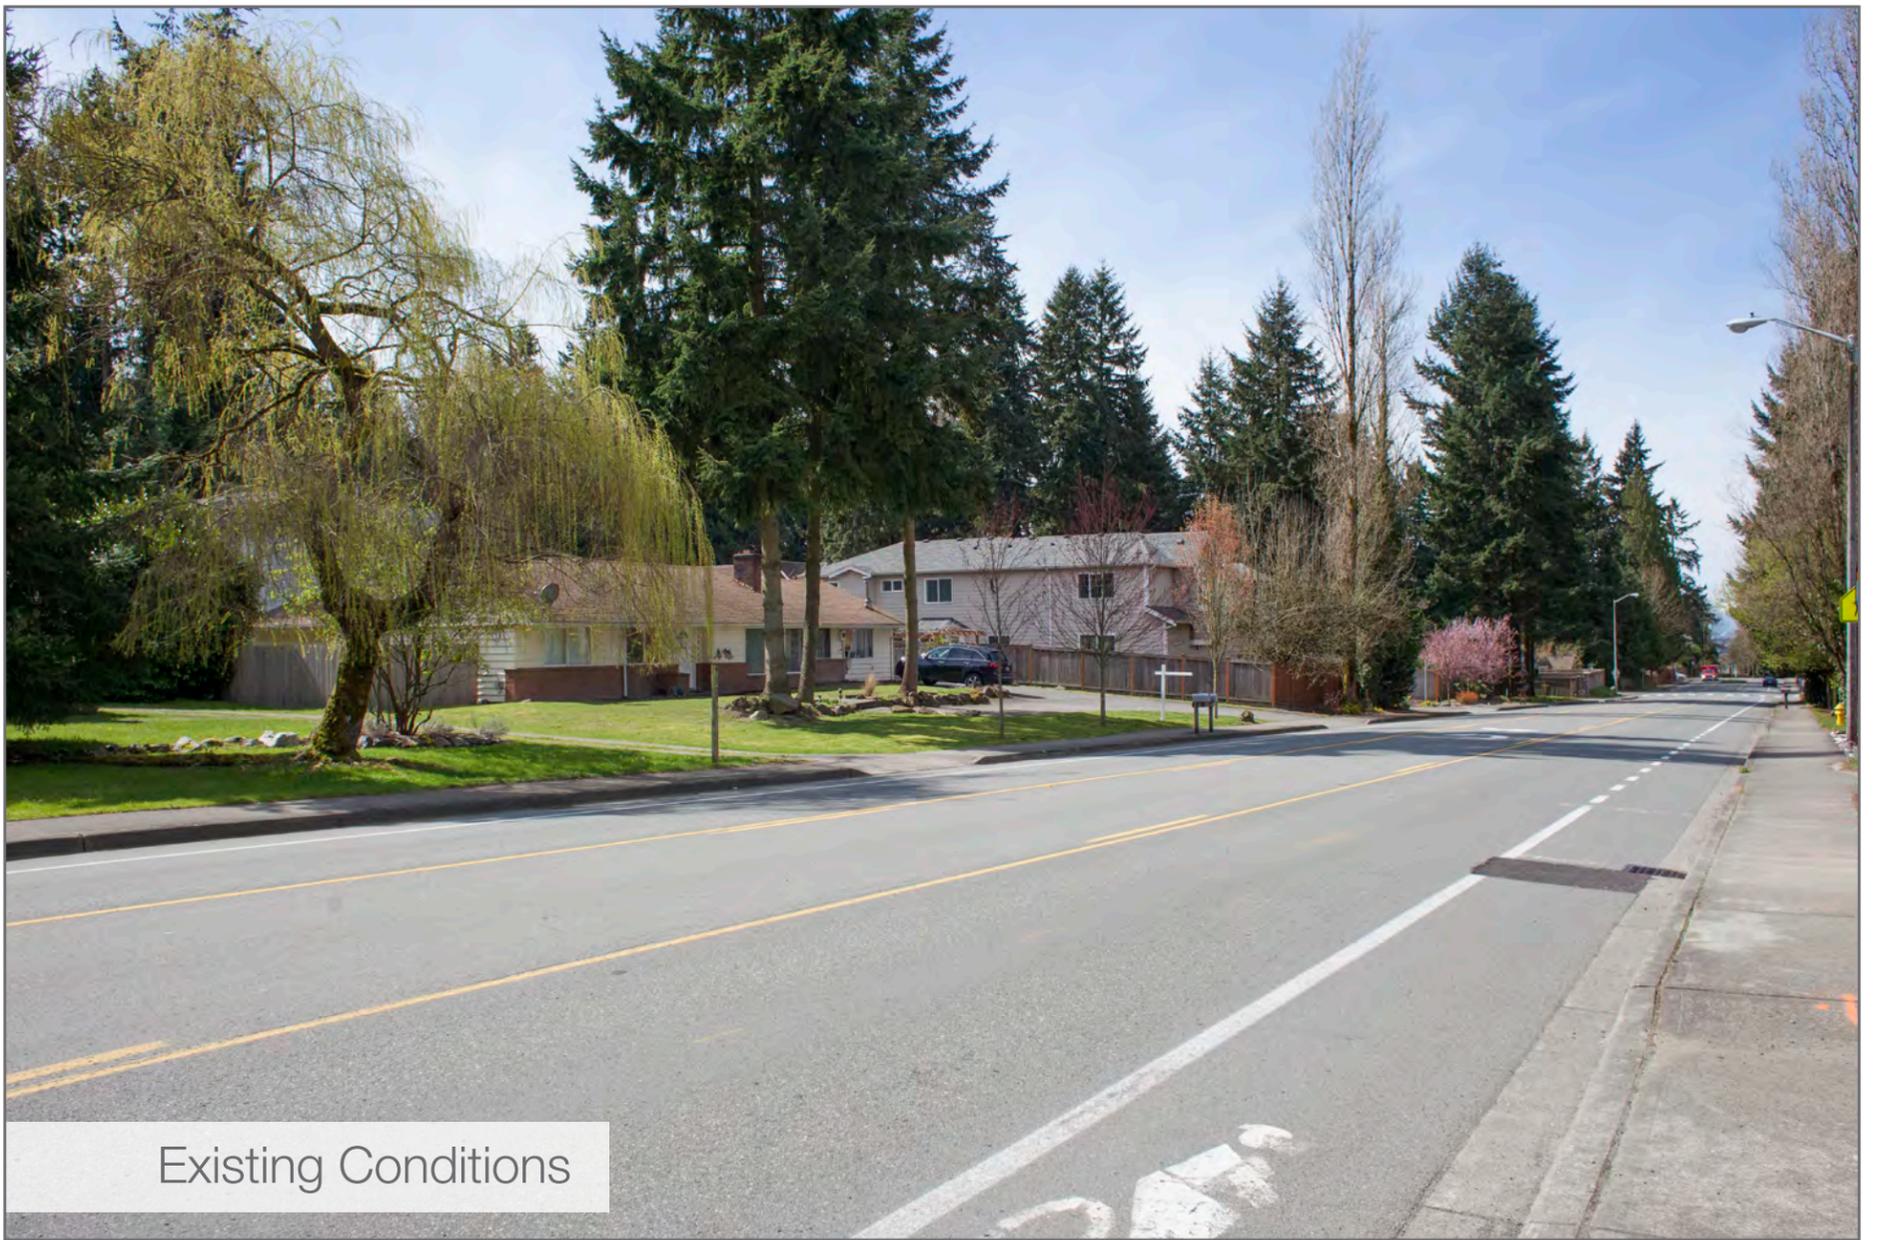
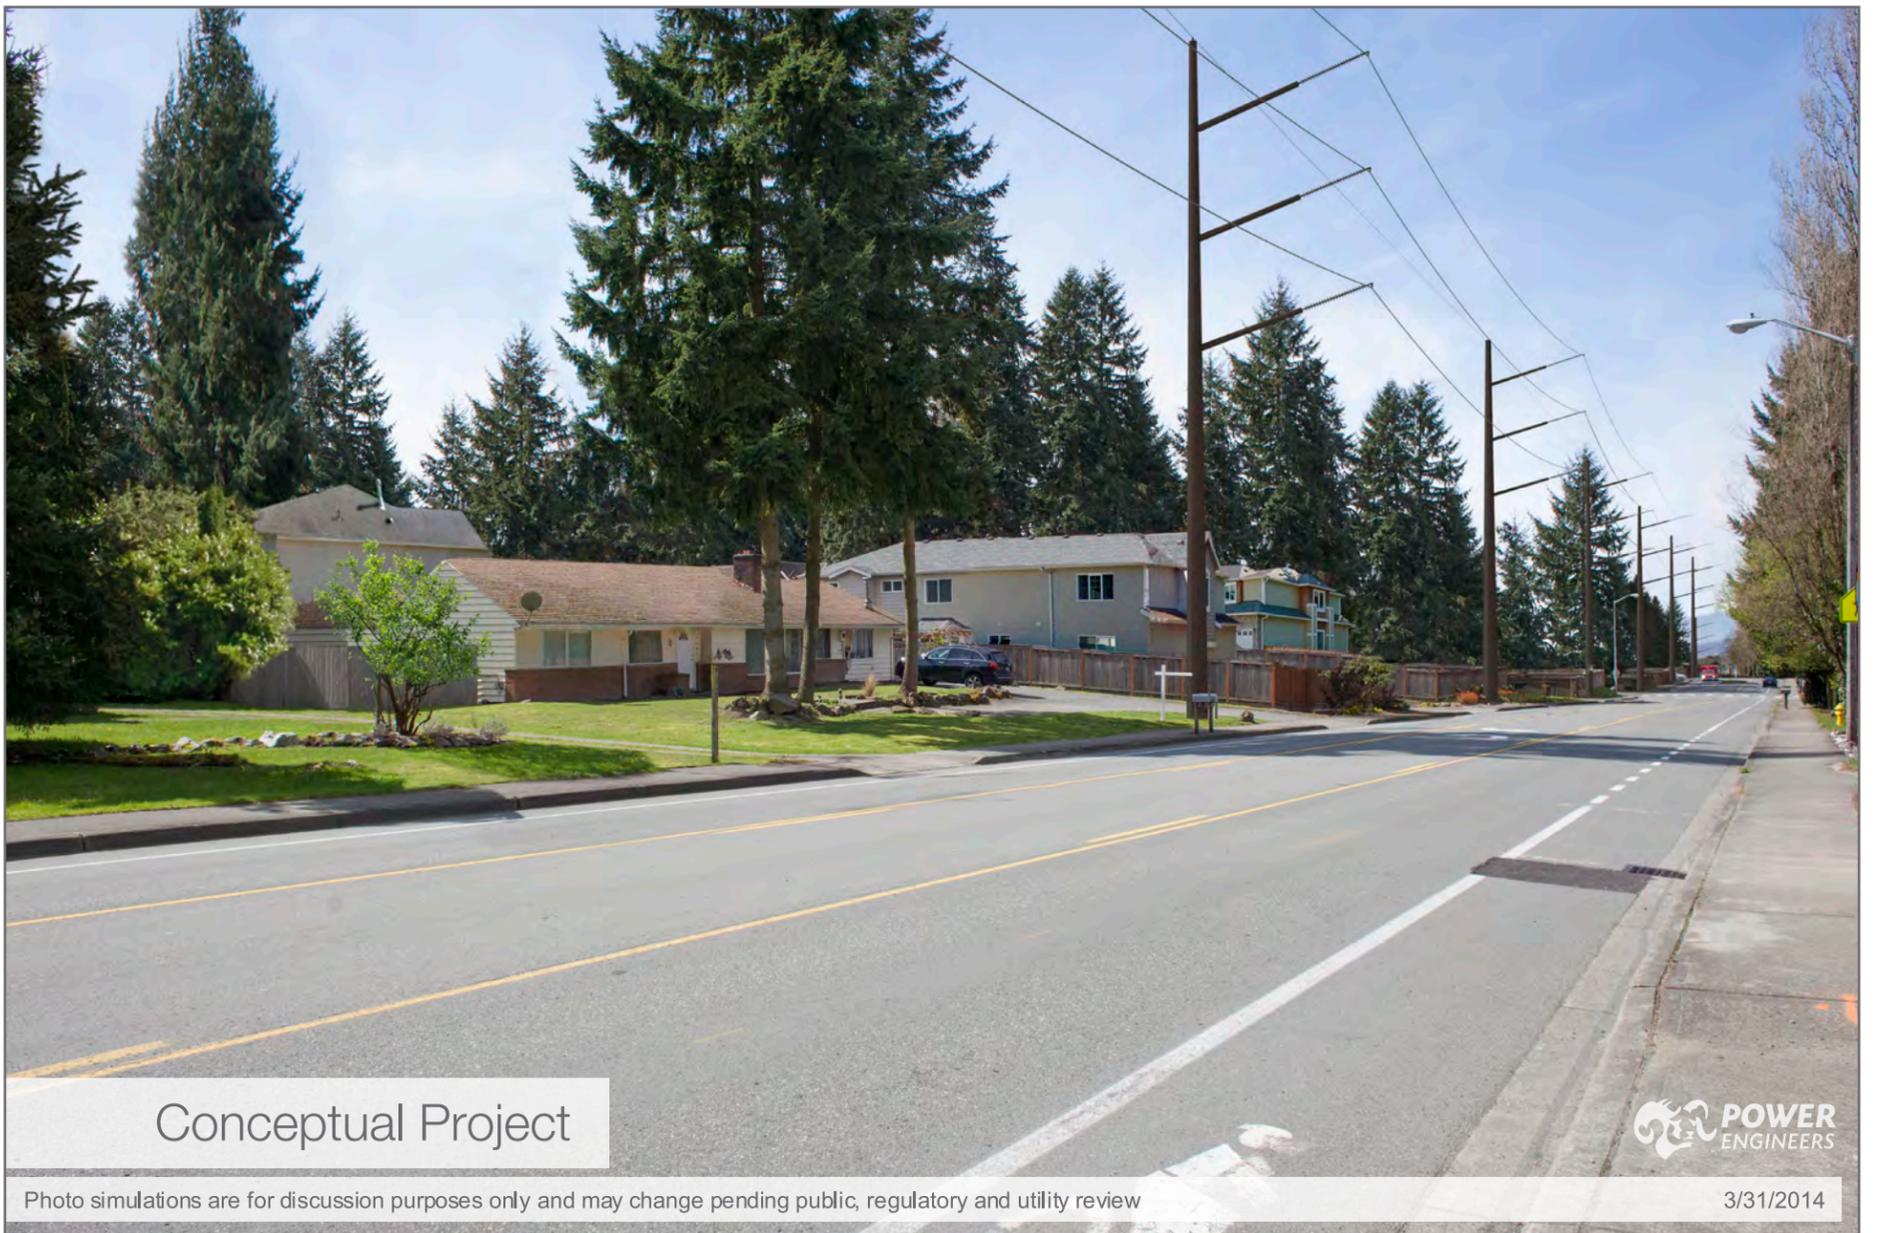
KOP NORTH 10 SEGMENT B

Address	12056 NE 70th St
Date	3/31/2014
Time	1:05 PM
Viewing Direction	West
Structure	G3-2

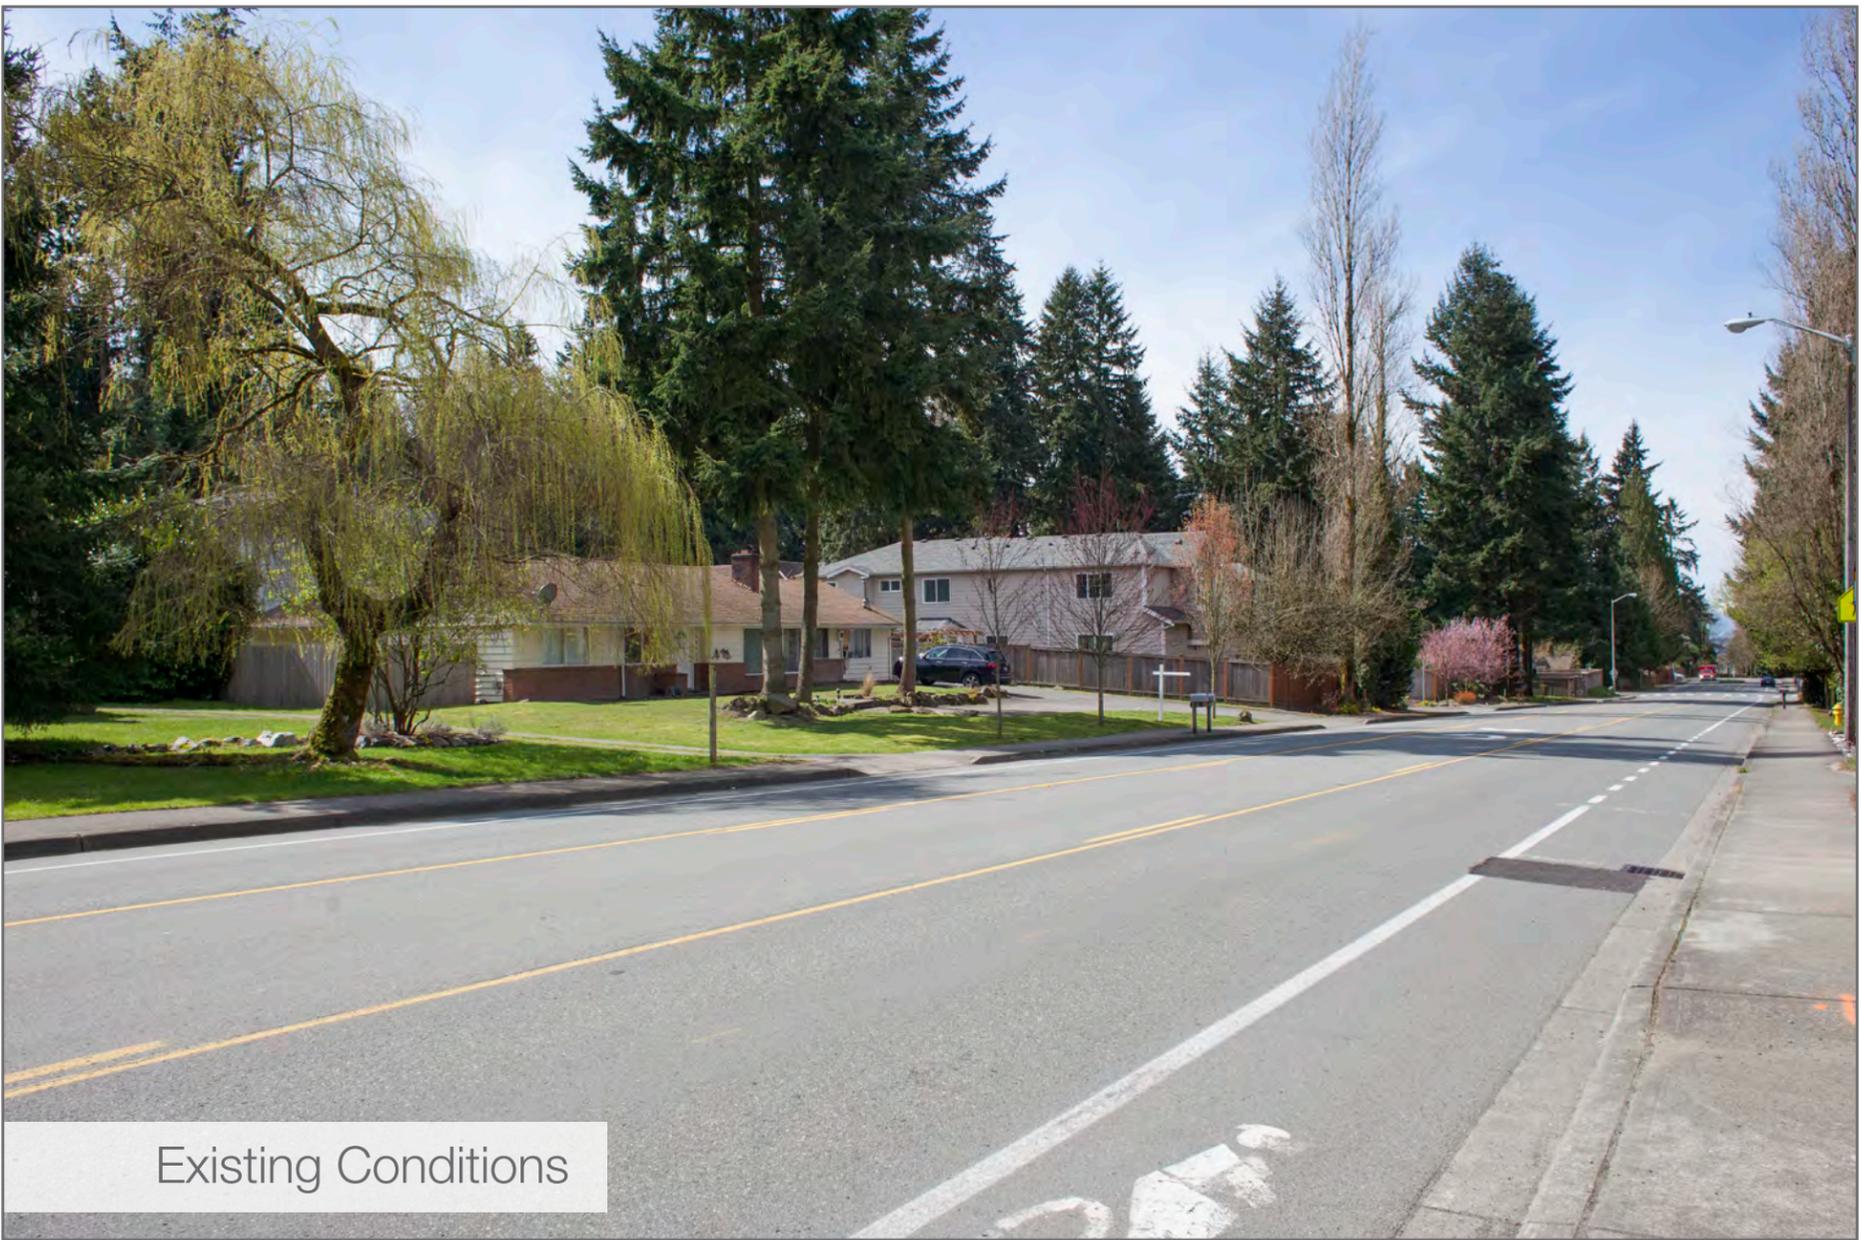
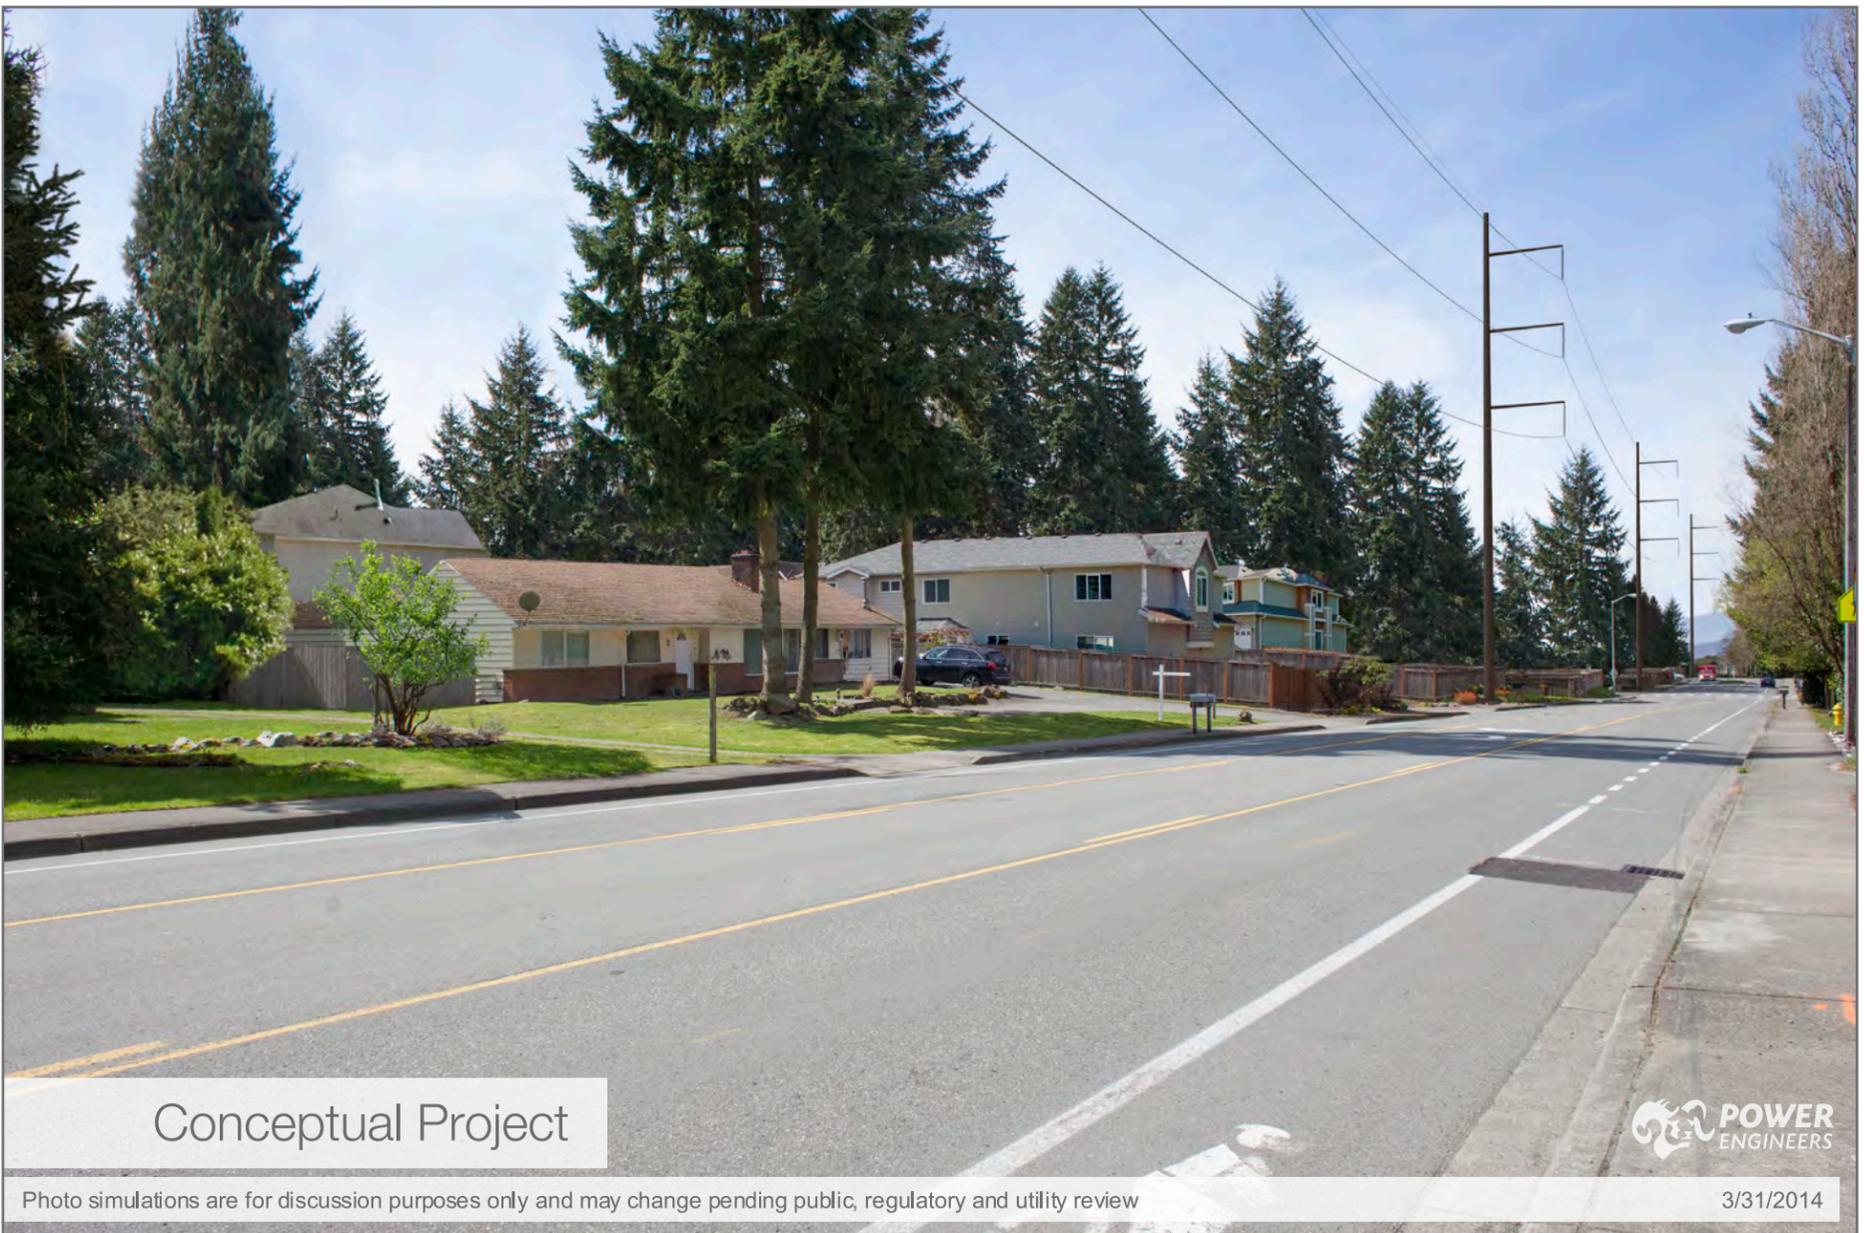
KOP NORTH 10 SEGMENT B

Address	12056 NE 70th St
Date	3/31/2014
Time	1:05 PM
Viewing Direction	West
Structure	G3-4
