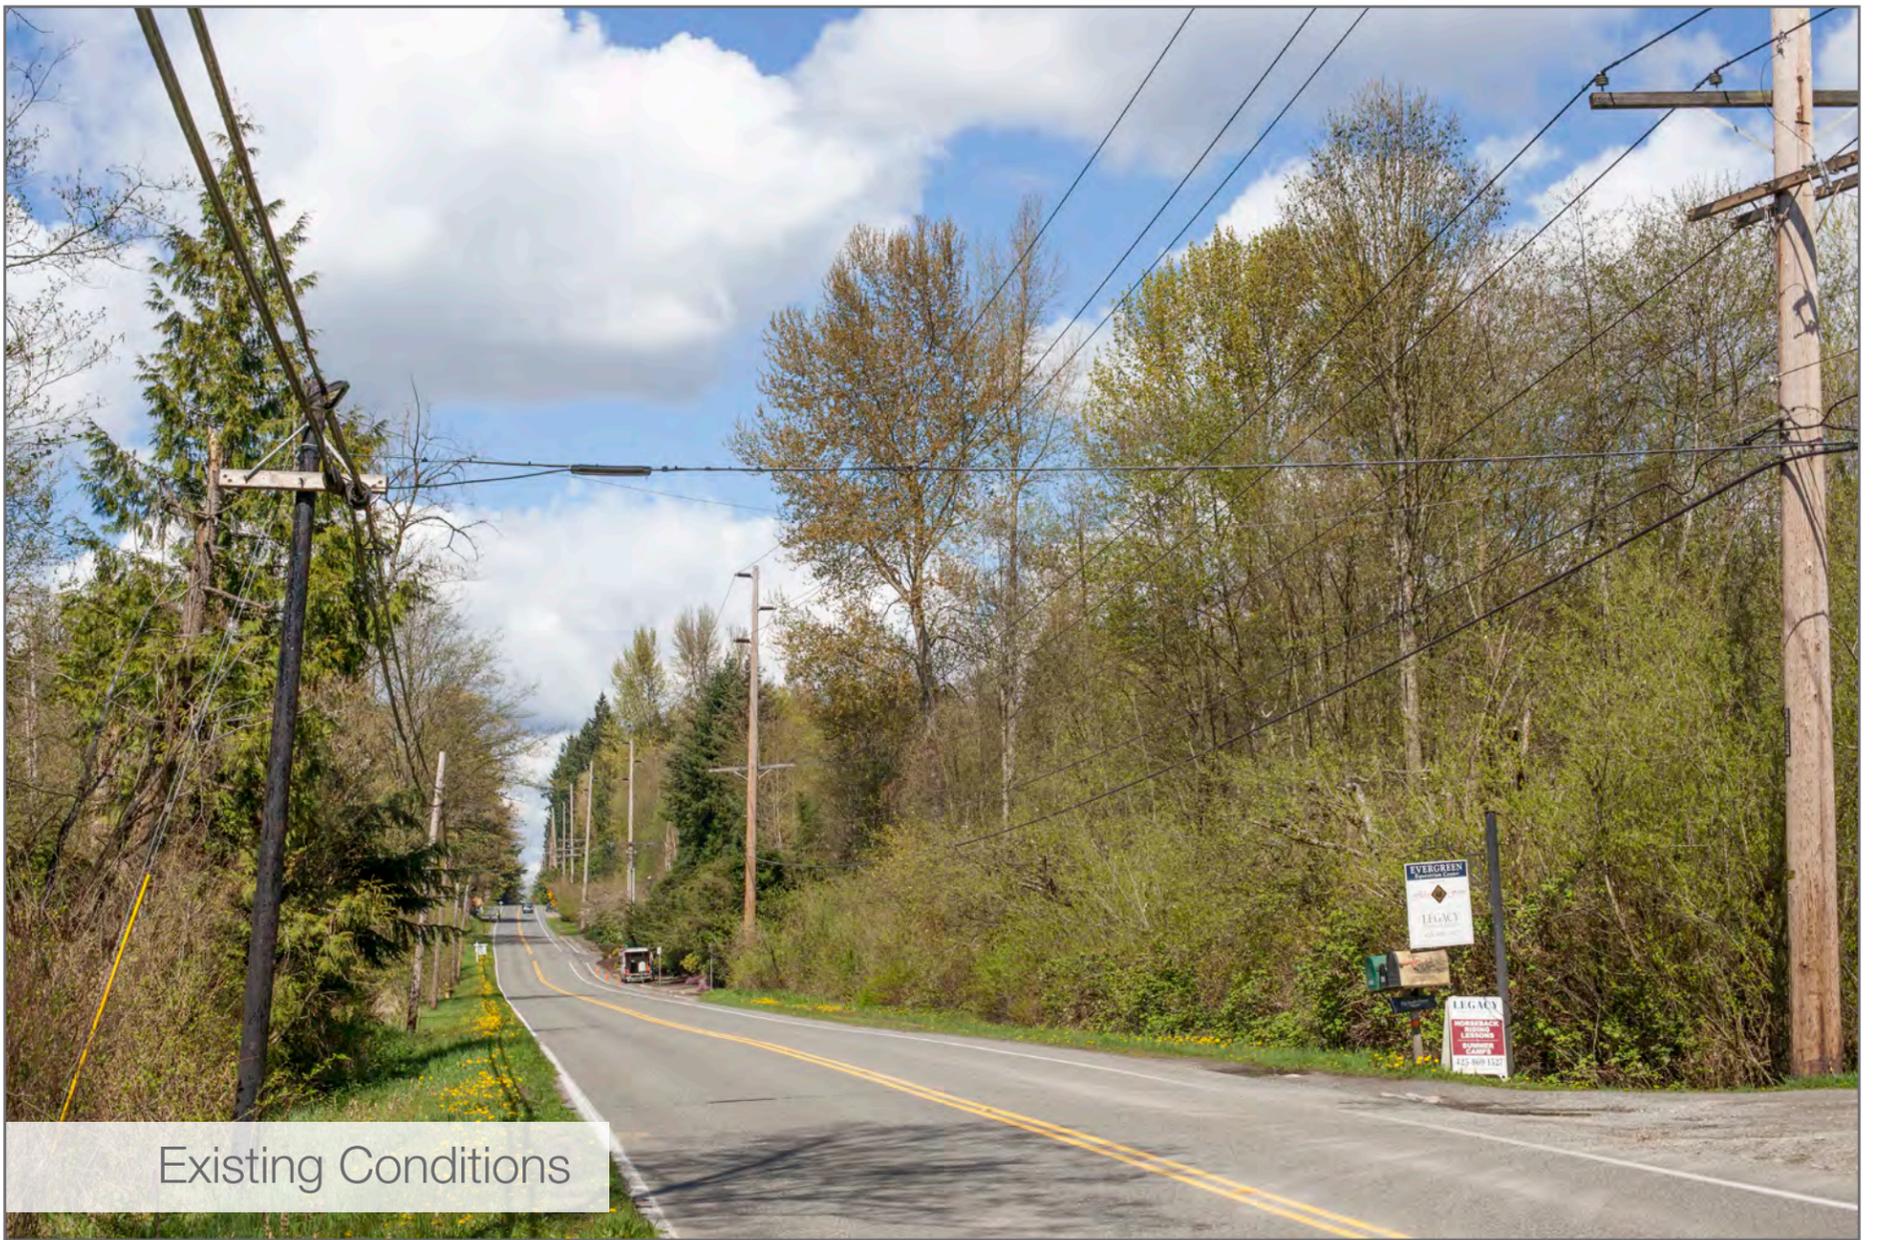
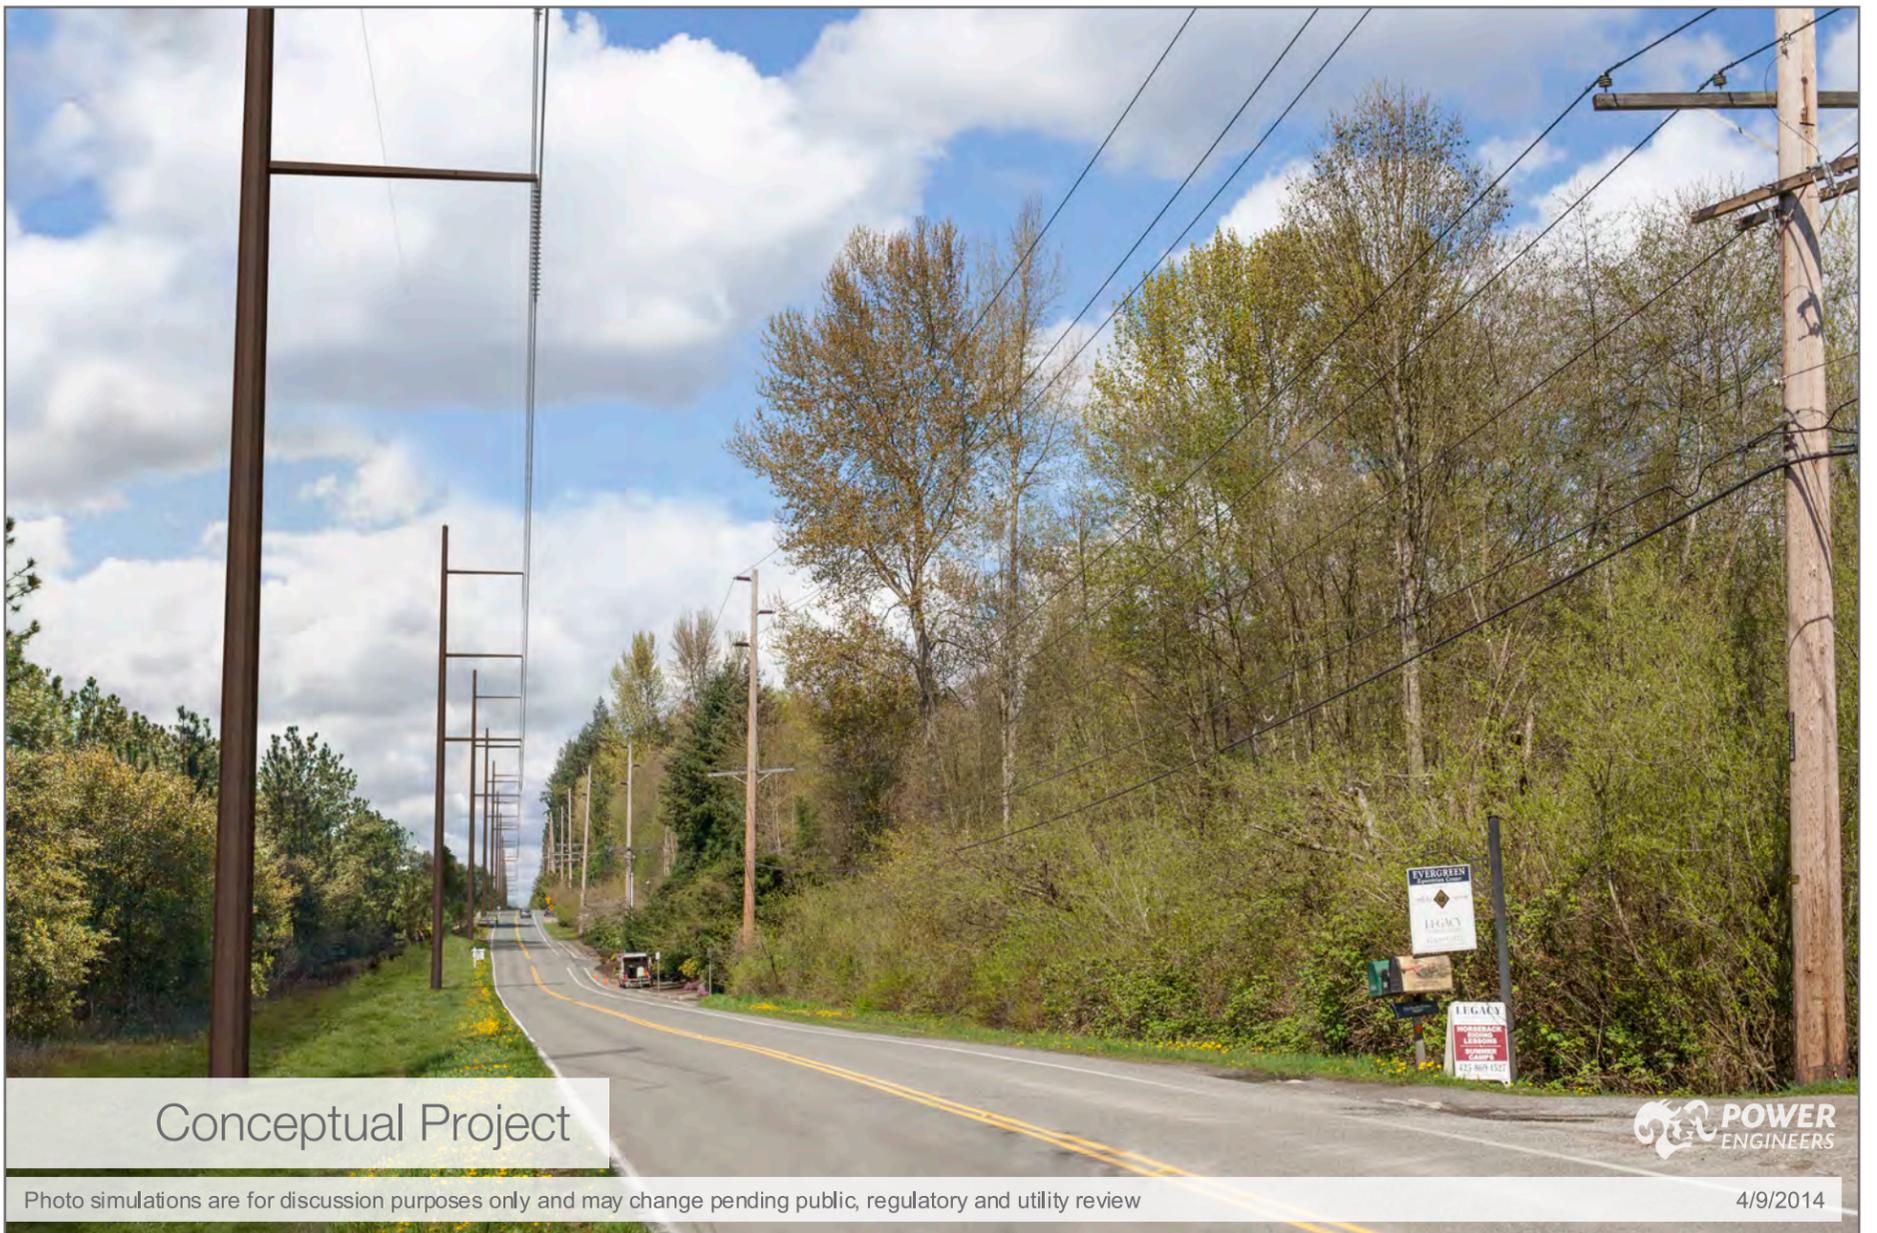
KOP NORTH 9 SEGMENT B

Address	4630 116th Ave NE
Date	4/9/2014
Time	2:00 PM
Viewing Direction	North
Structure	G3-4

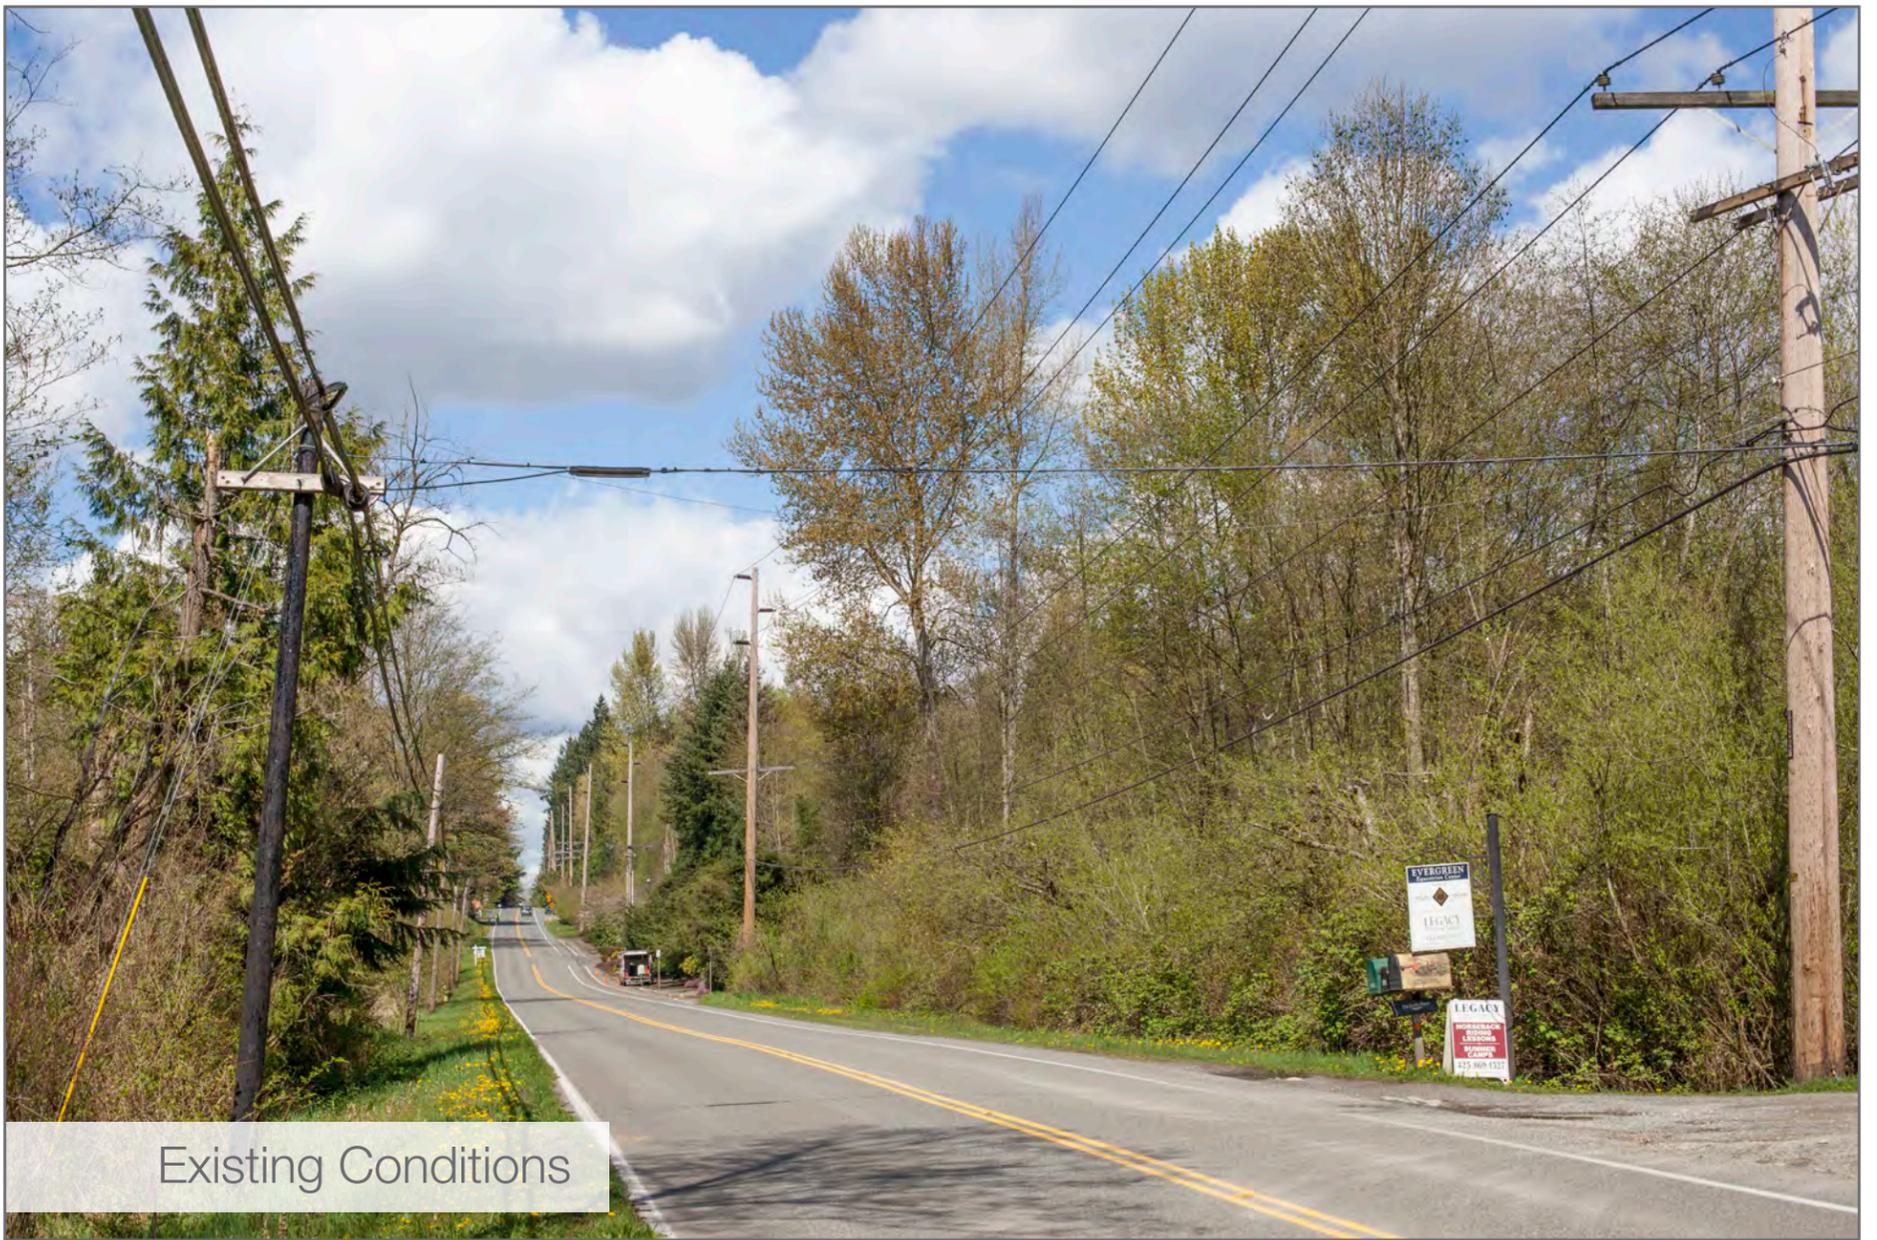
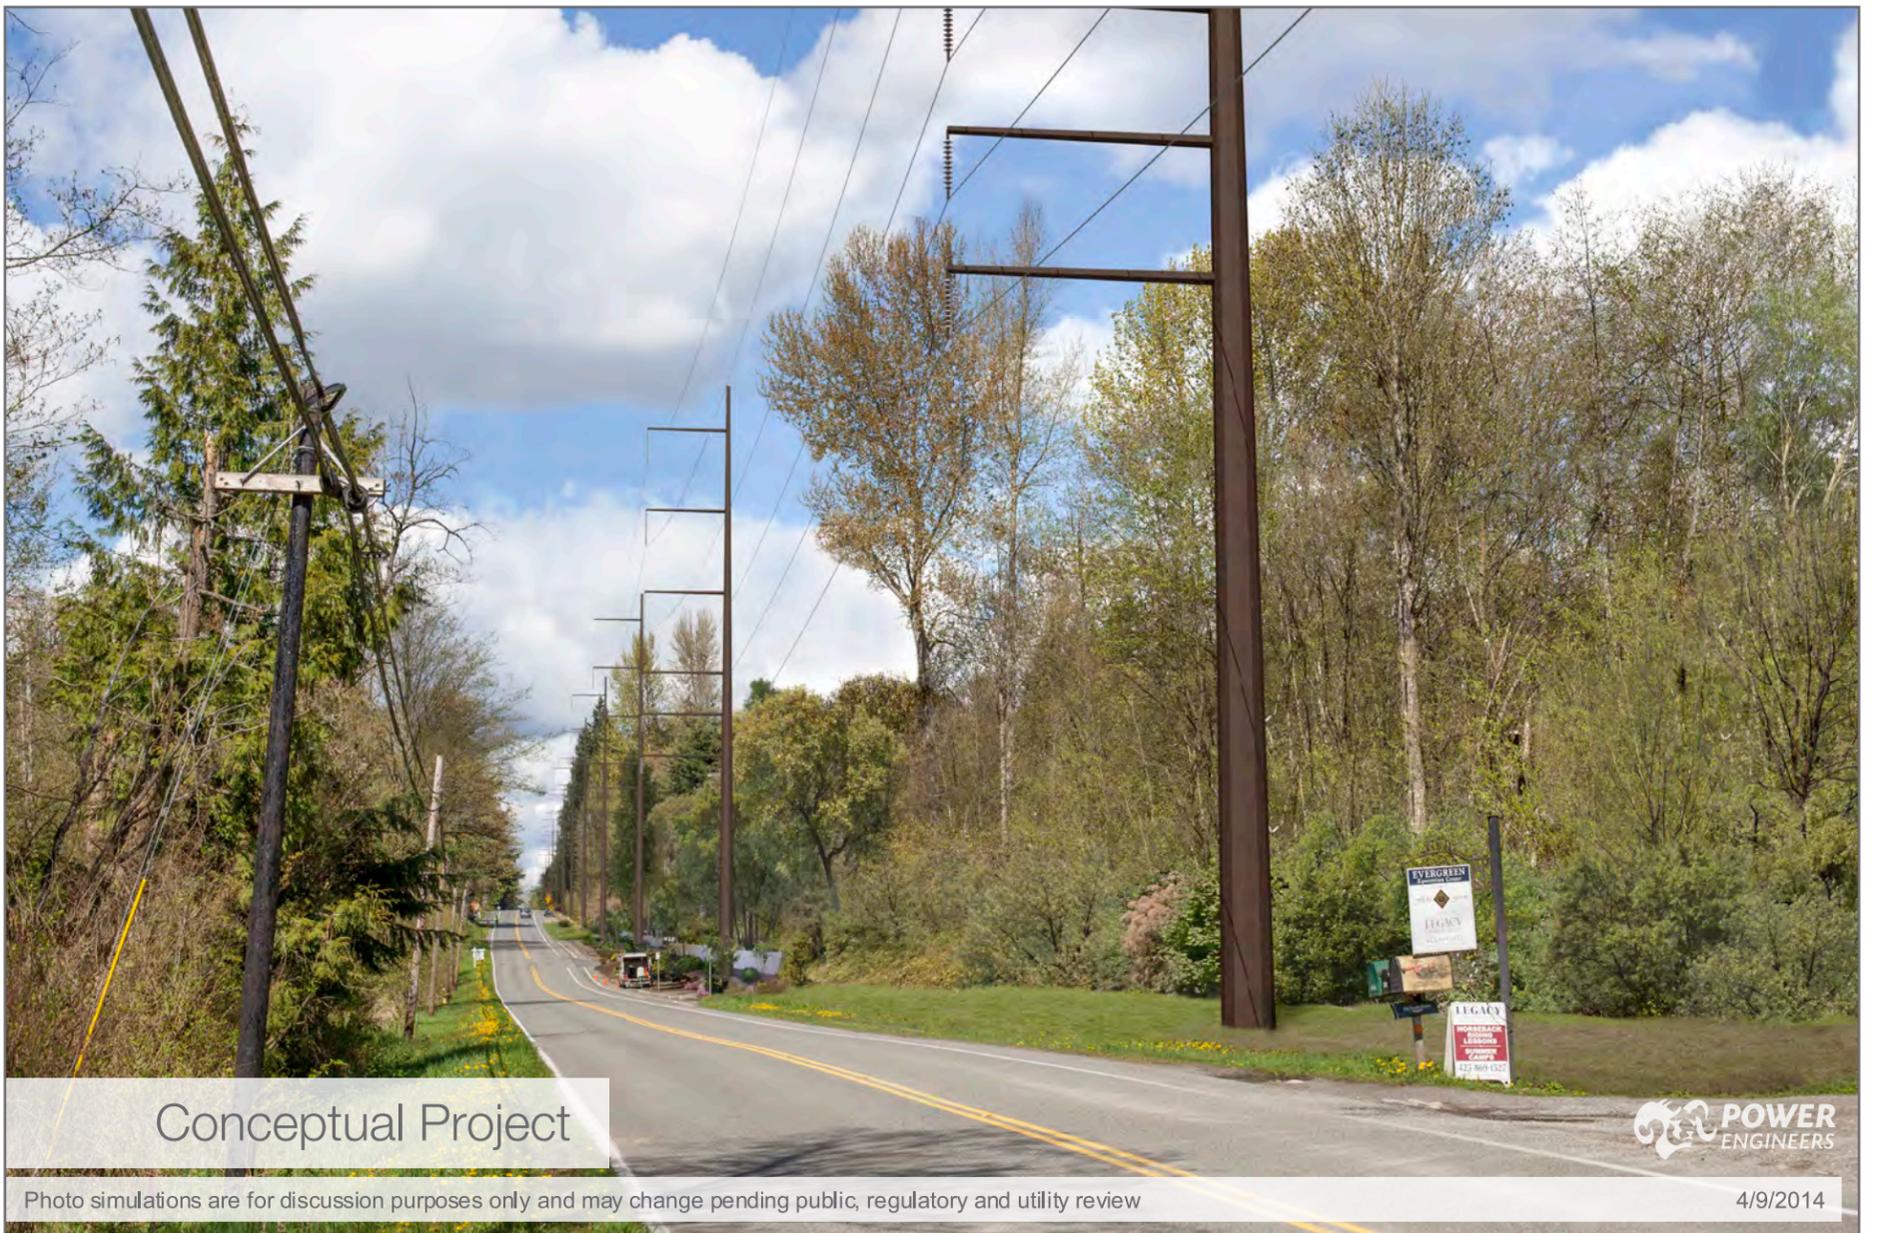
KOP NORTH 9 SEGMENT B

Address	4630 116th Ave NE
Date	4/9/2014
Time	2:00 PM
Viewing Direction	North
Structure	G3-8

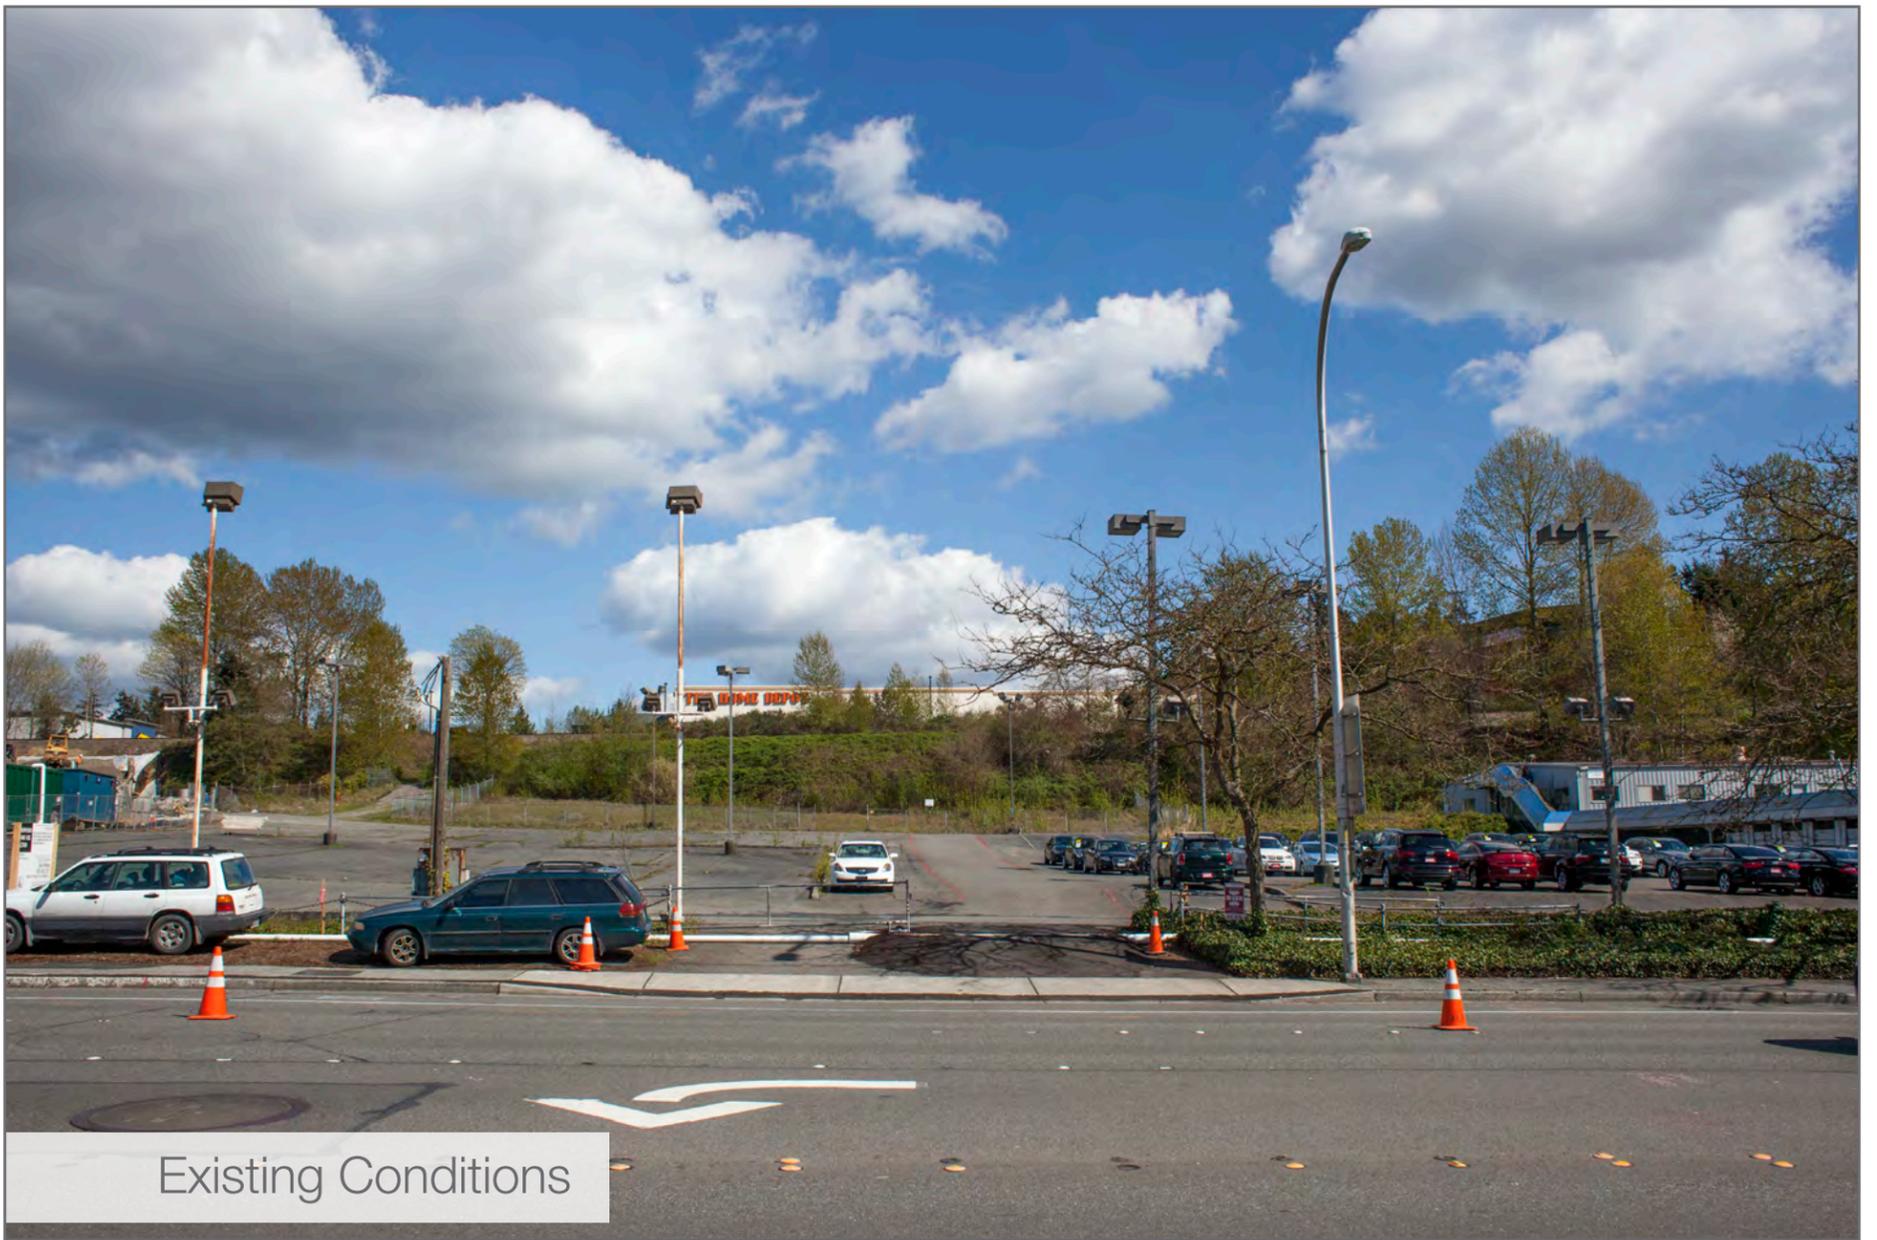
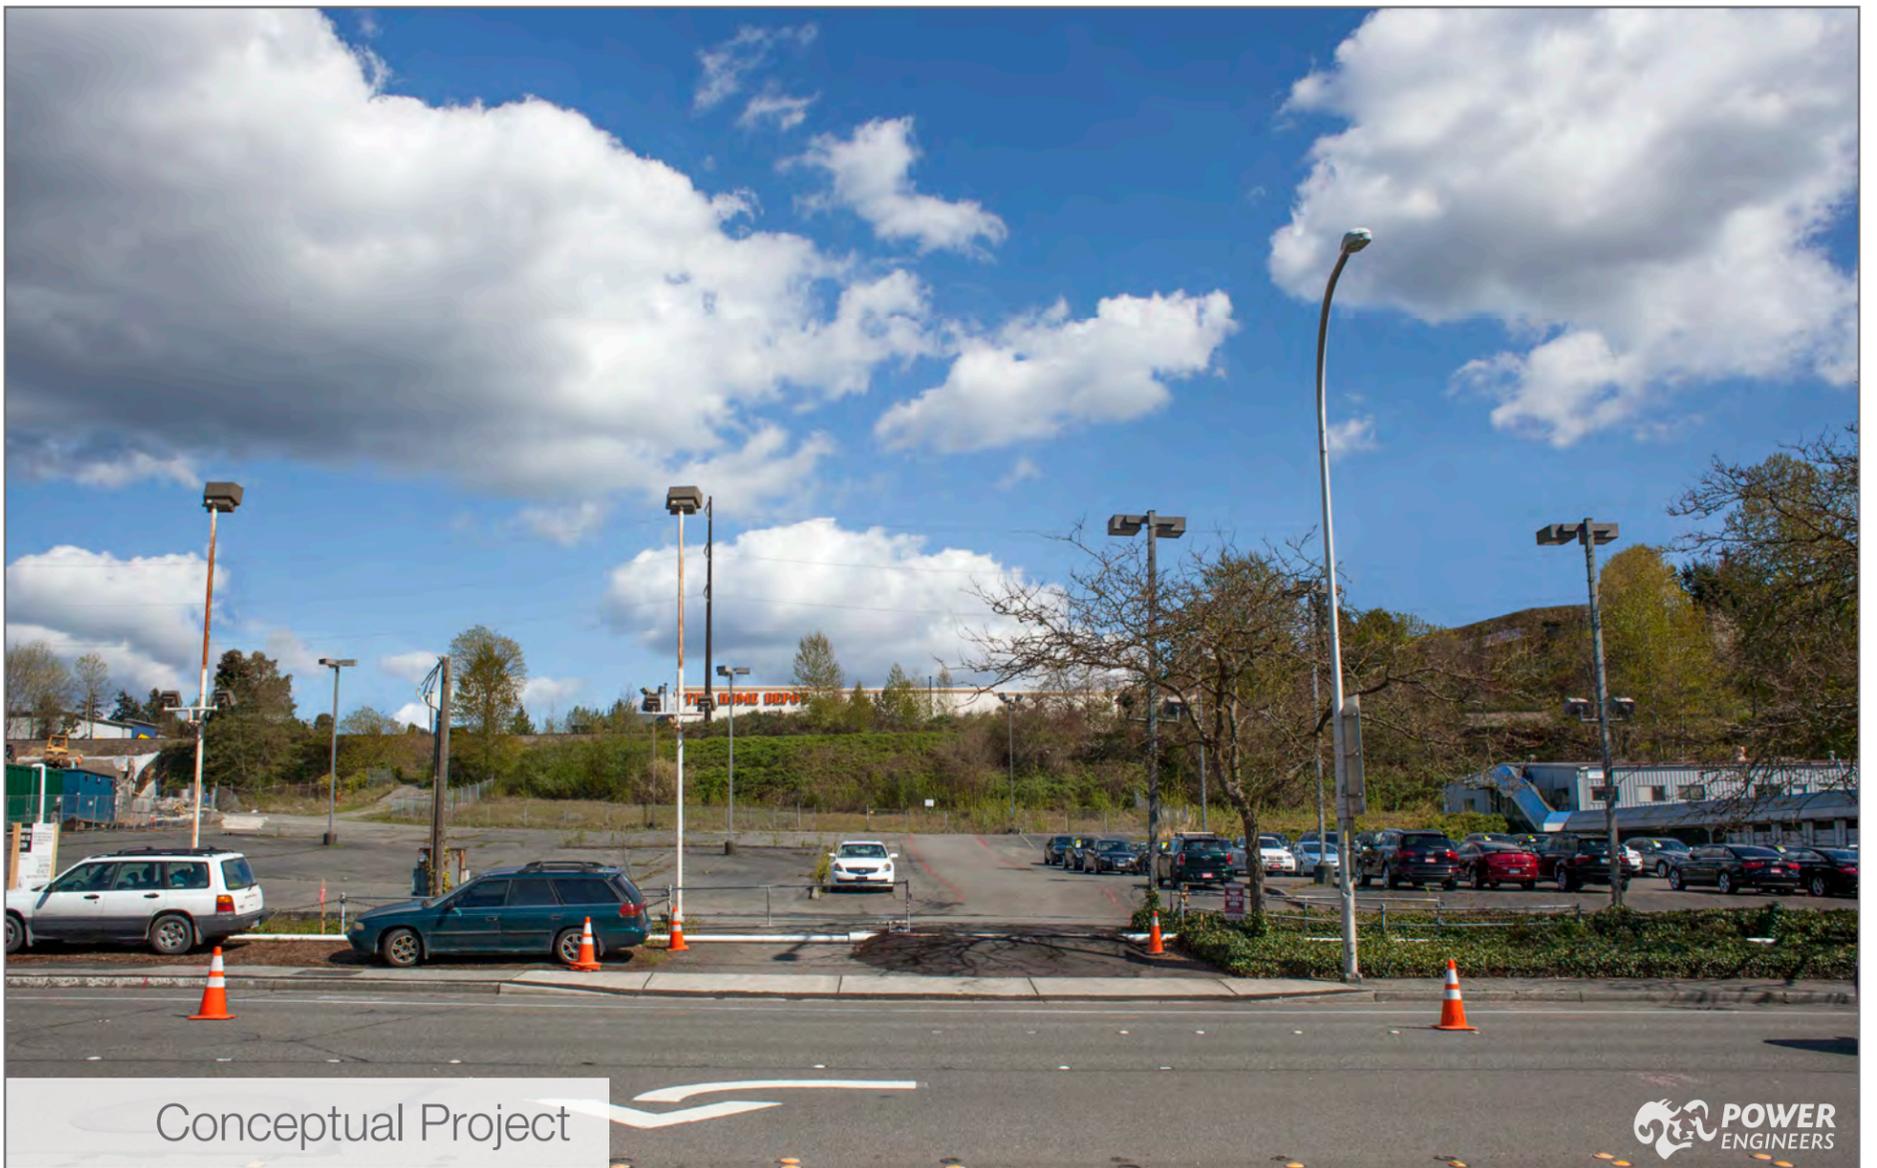
KOP NORTH 6 SEGMENT B

Address	293 116th Ave NE
Date	4/9/2014
Time	2:42 PM
Viewing Direction	East
Structure	G4-5

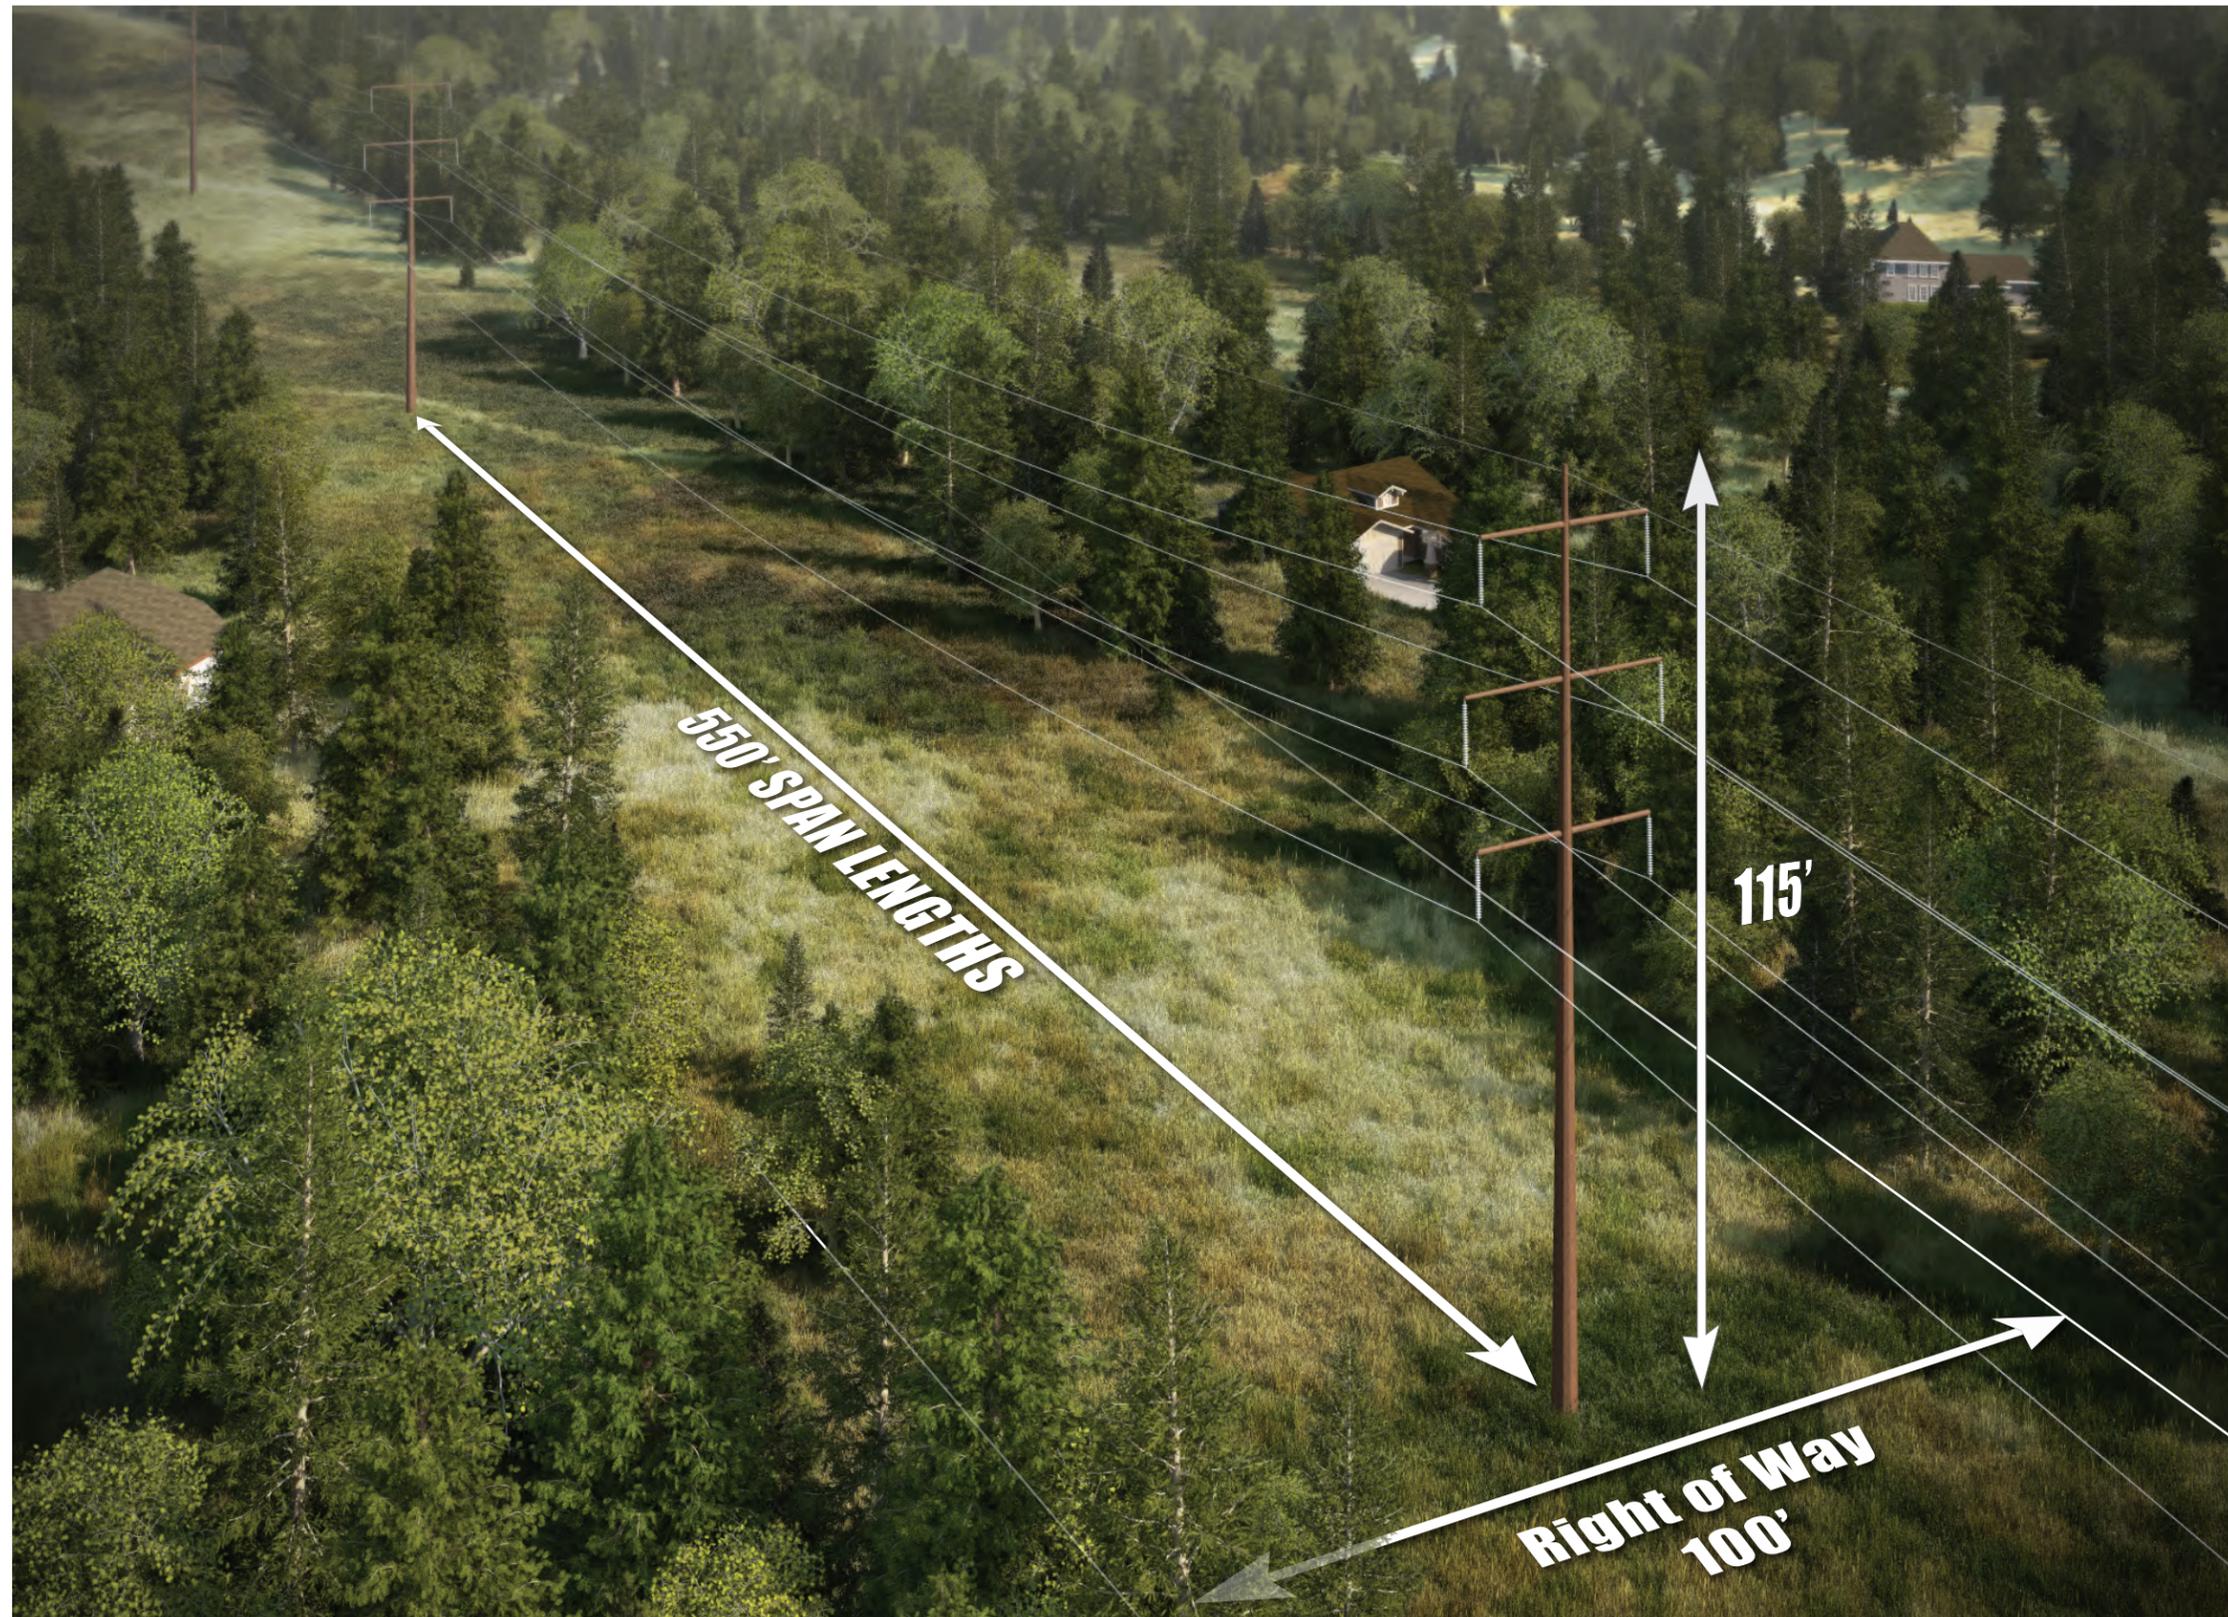
POLE TYPE G2-1

- Height: 115'
- Right of Way: 100'
- Span Lengths: 550'

Note: Span lengths and heights shown are typical and may vary due to localized site conditions and engineering requirements.

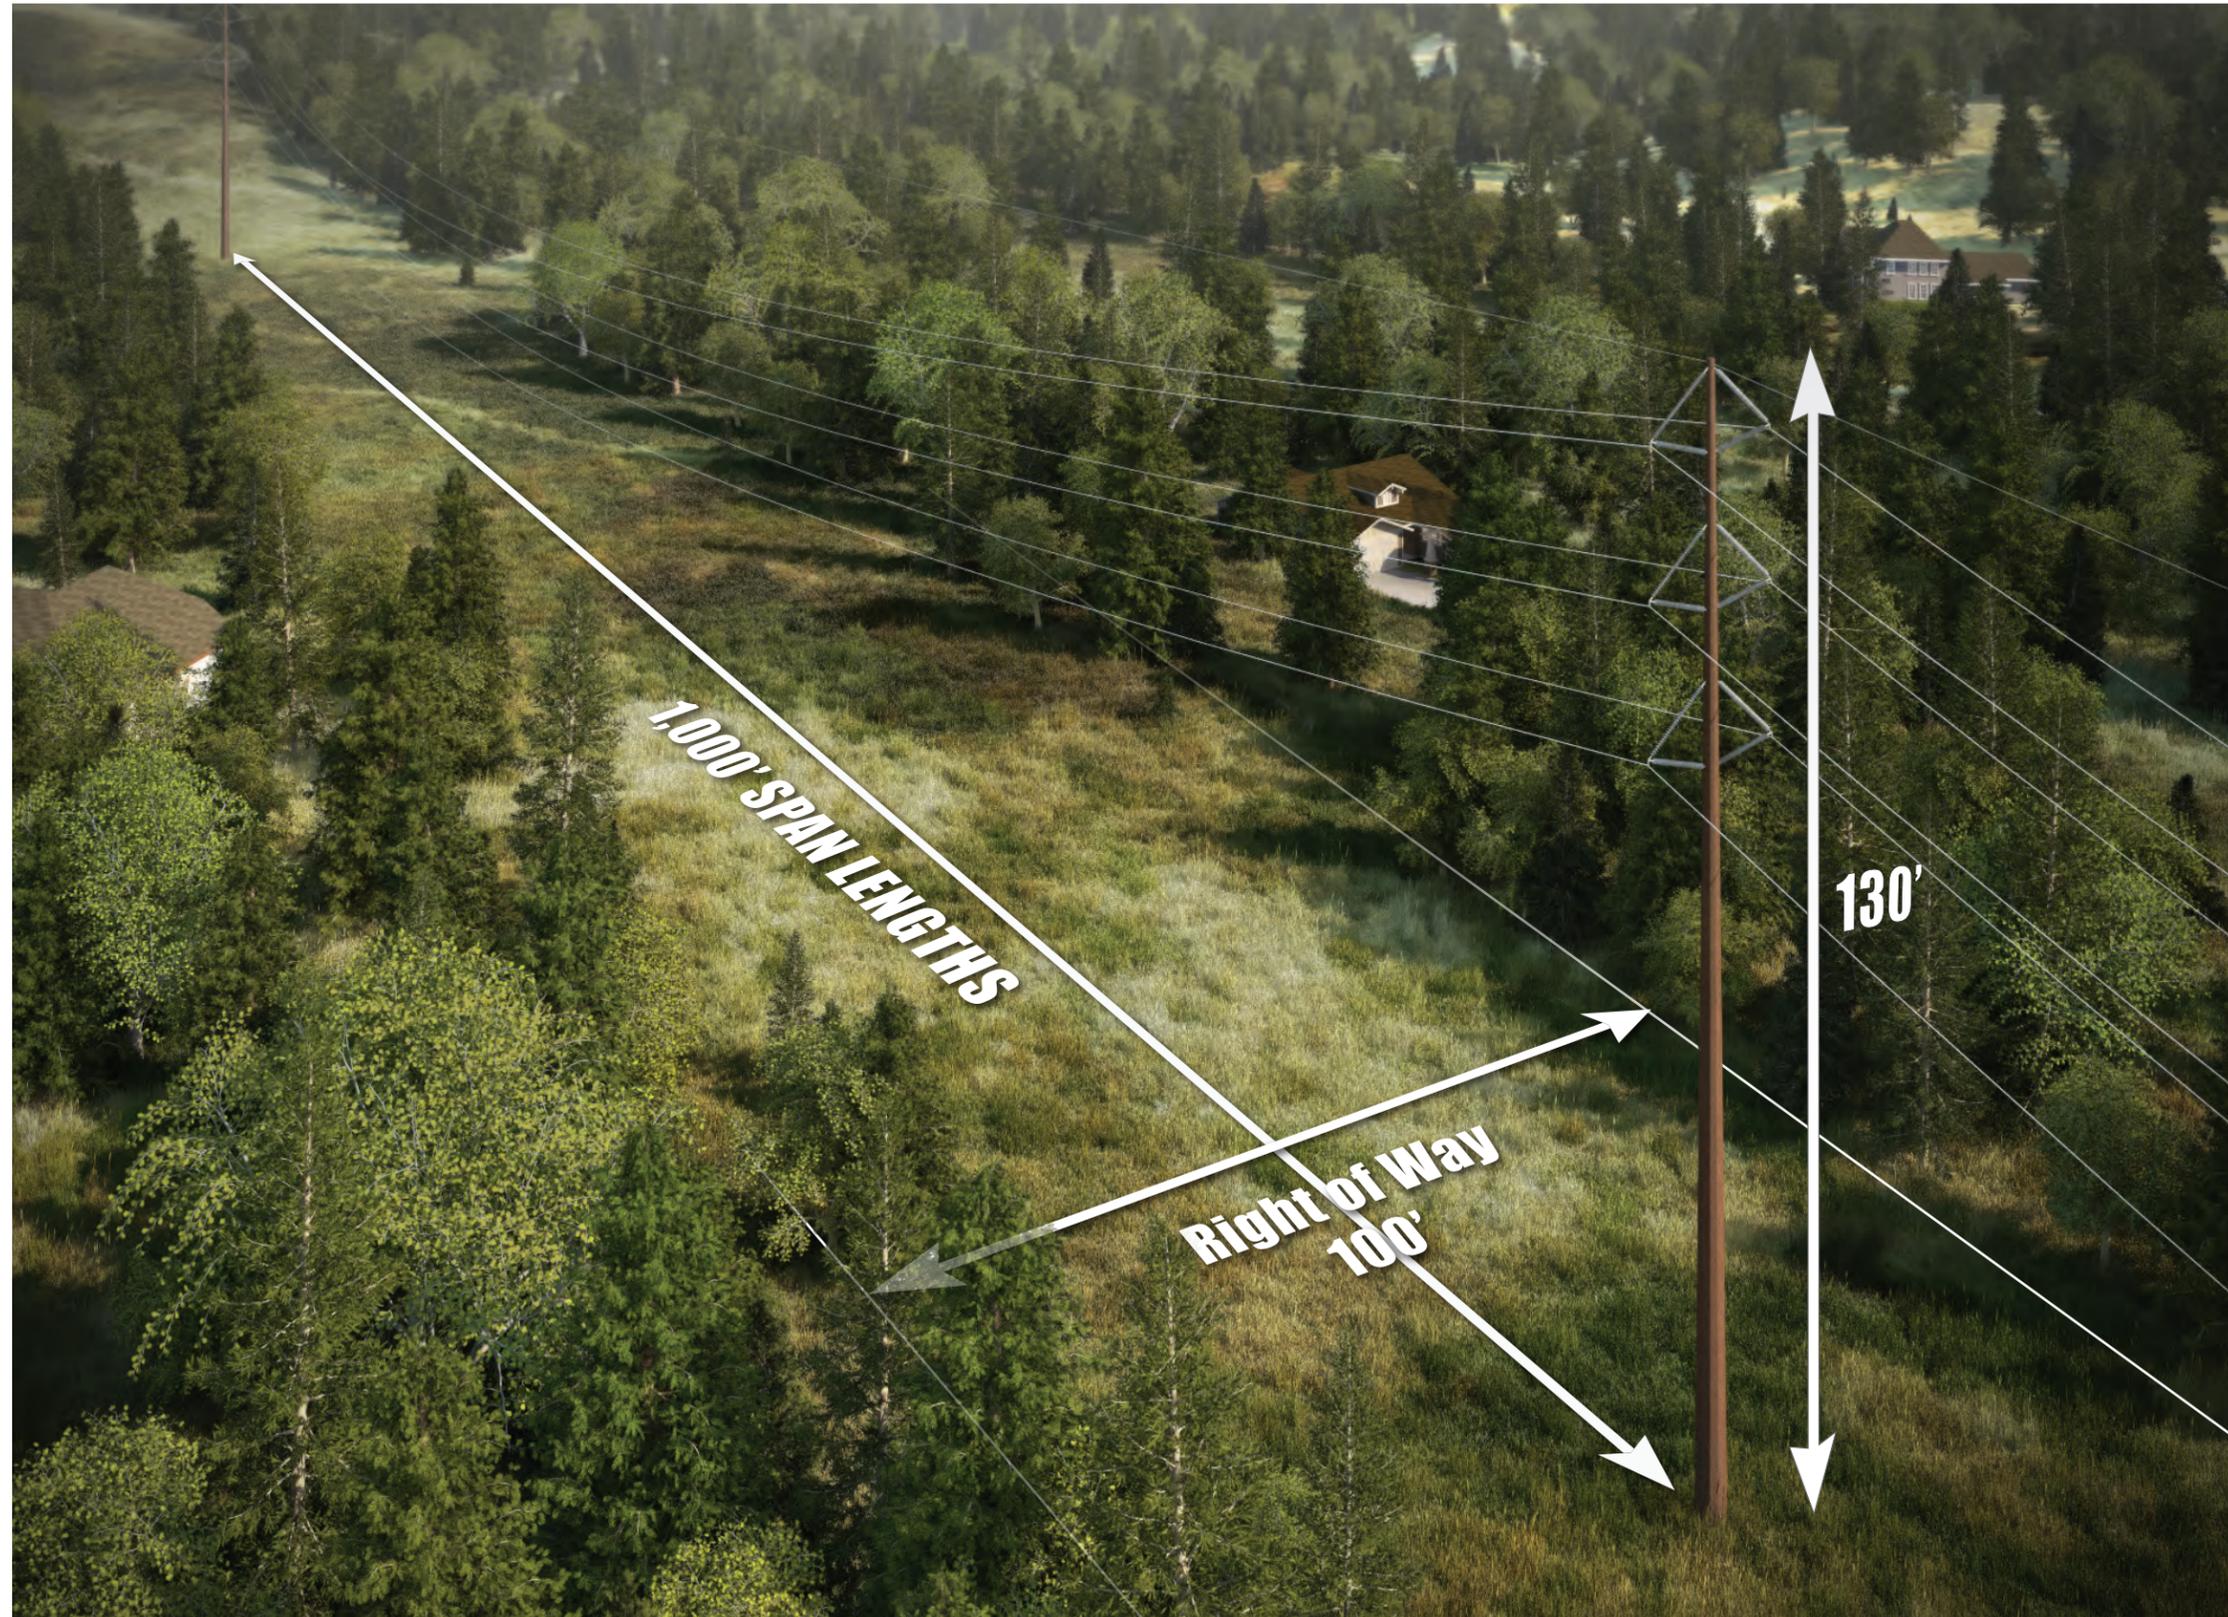
POLE TYPE G2-5

- Height: 130'
- Right of Way: 100'
- Span Lengths: 1,000'

Note: Span lengths and heights shown are typical and may vary due to localized site conditions and engineering requirements.
