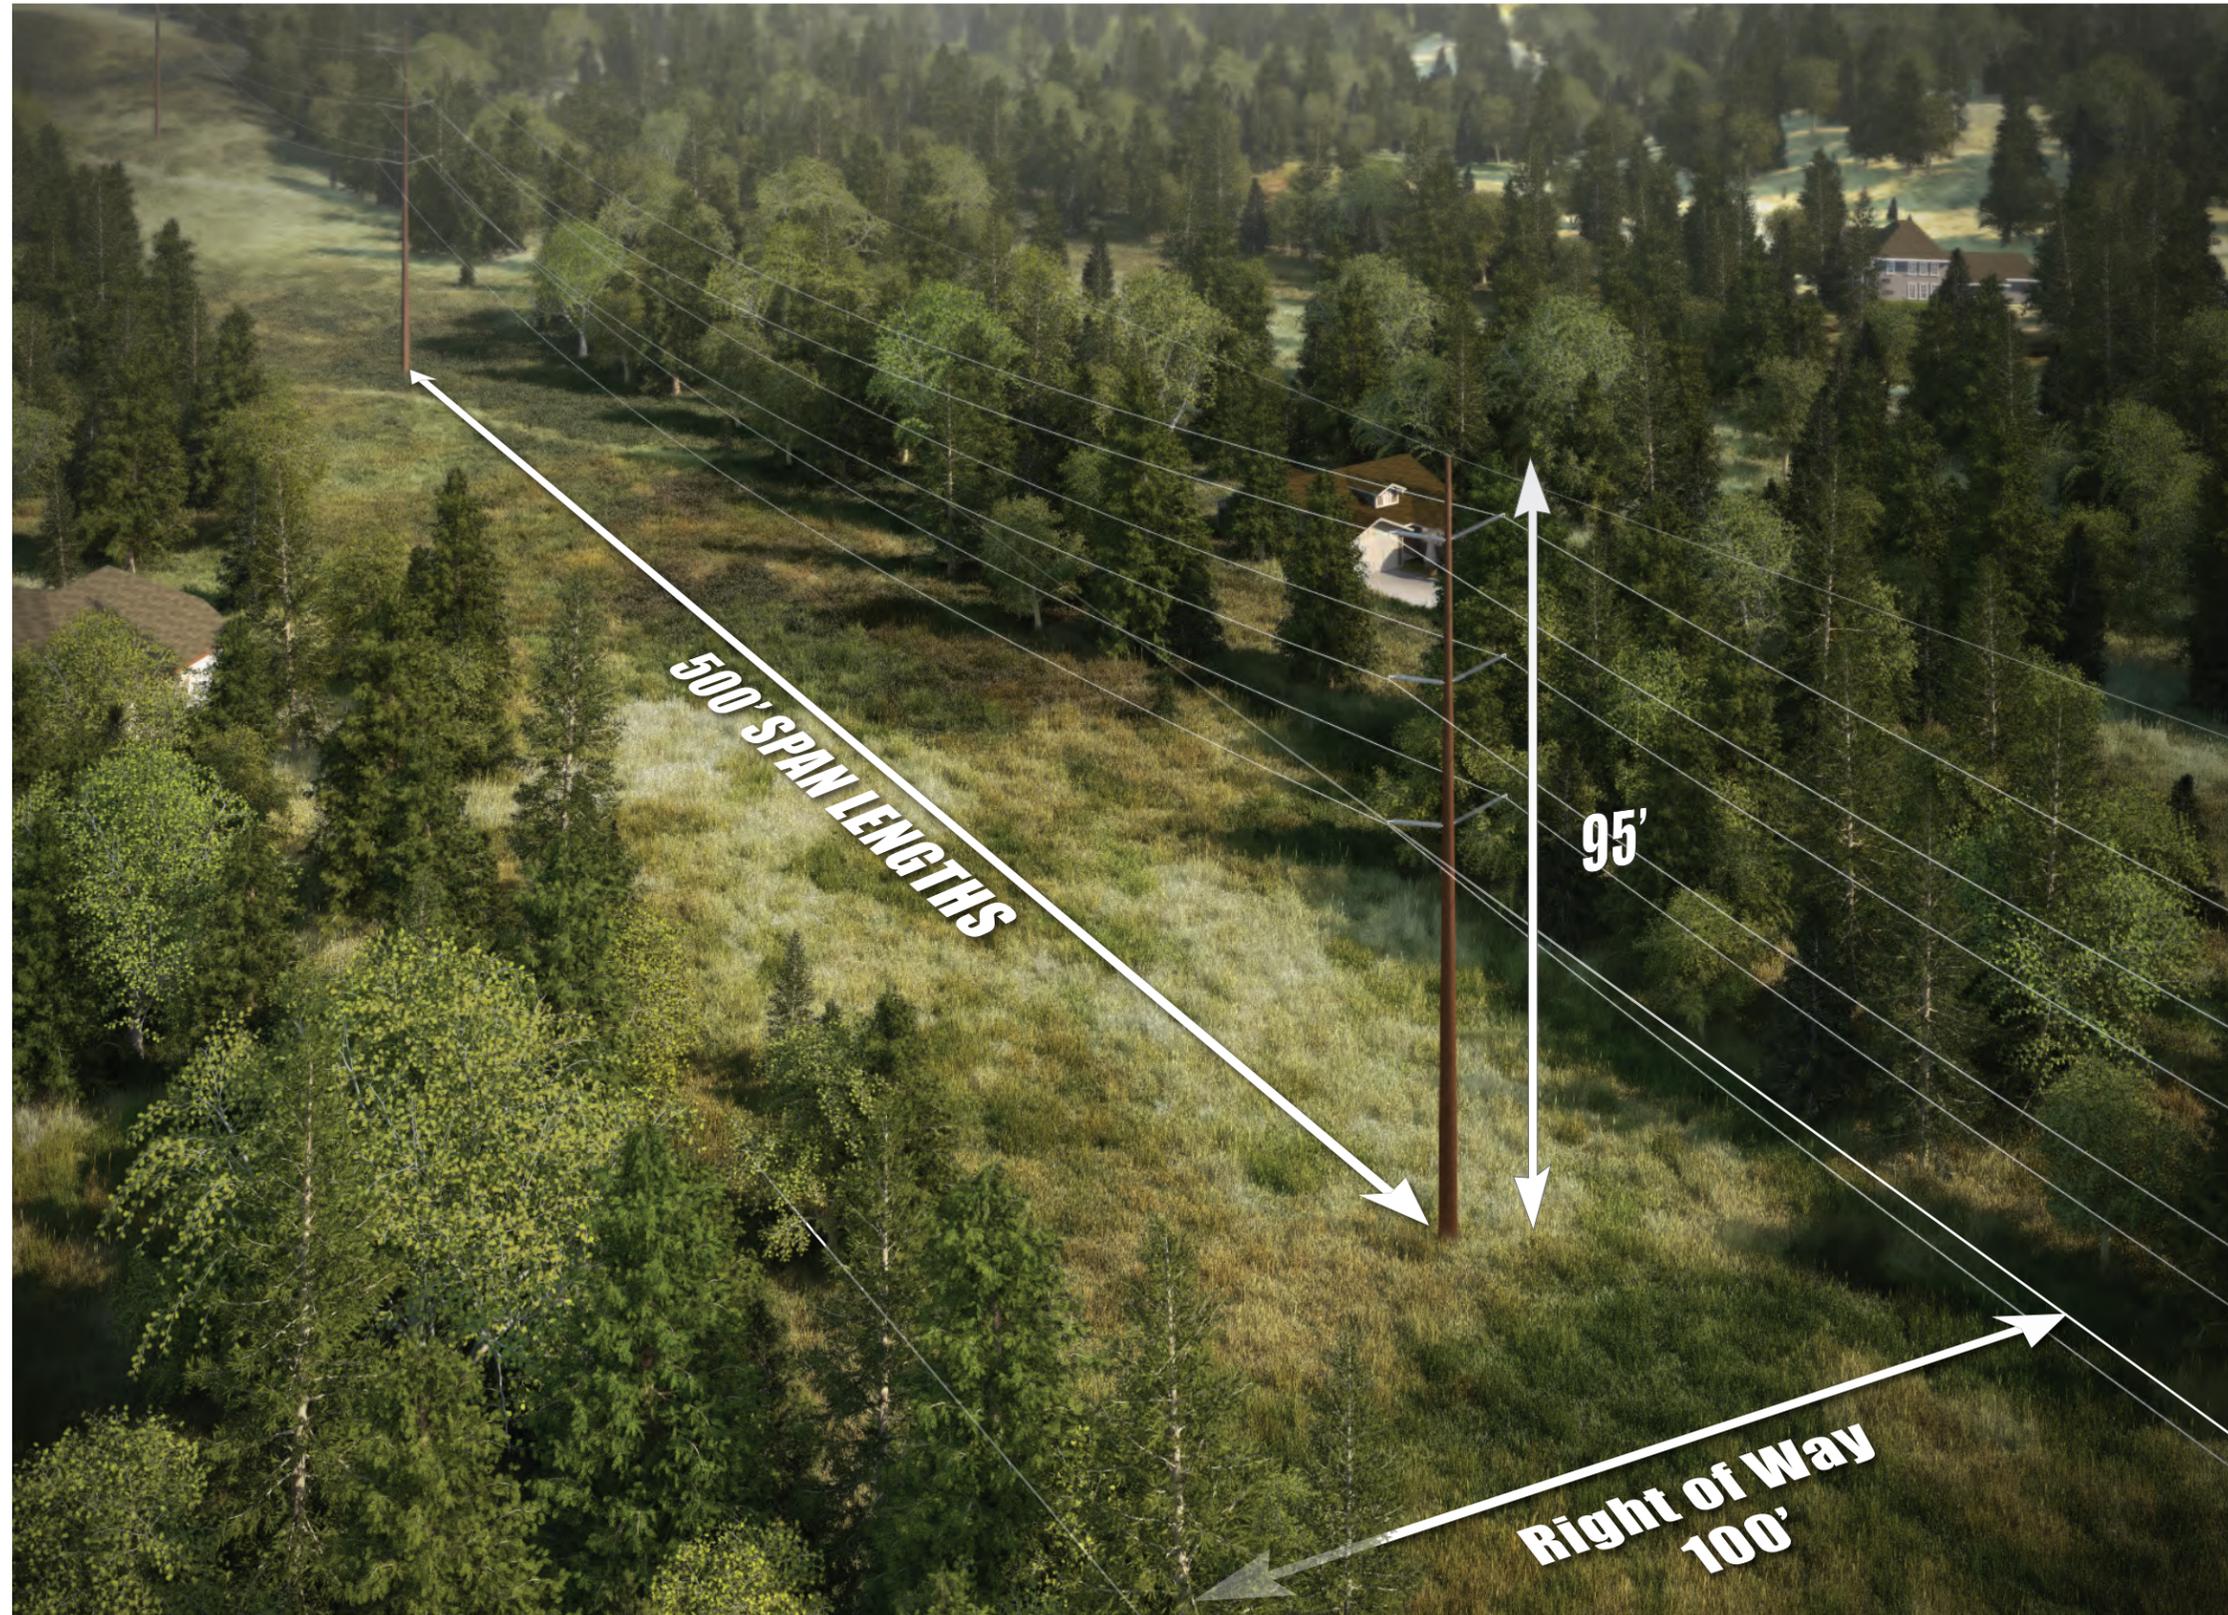
POLE TYPE G2-6

- Height: 95'
- Right of Way: 100'
- Span Lengths: 500'

Note: Span lengths and heights shown are typical and may vary due to localized site conditions and engineering requirements.

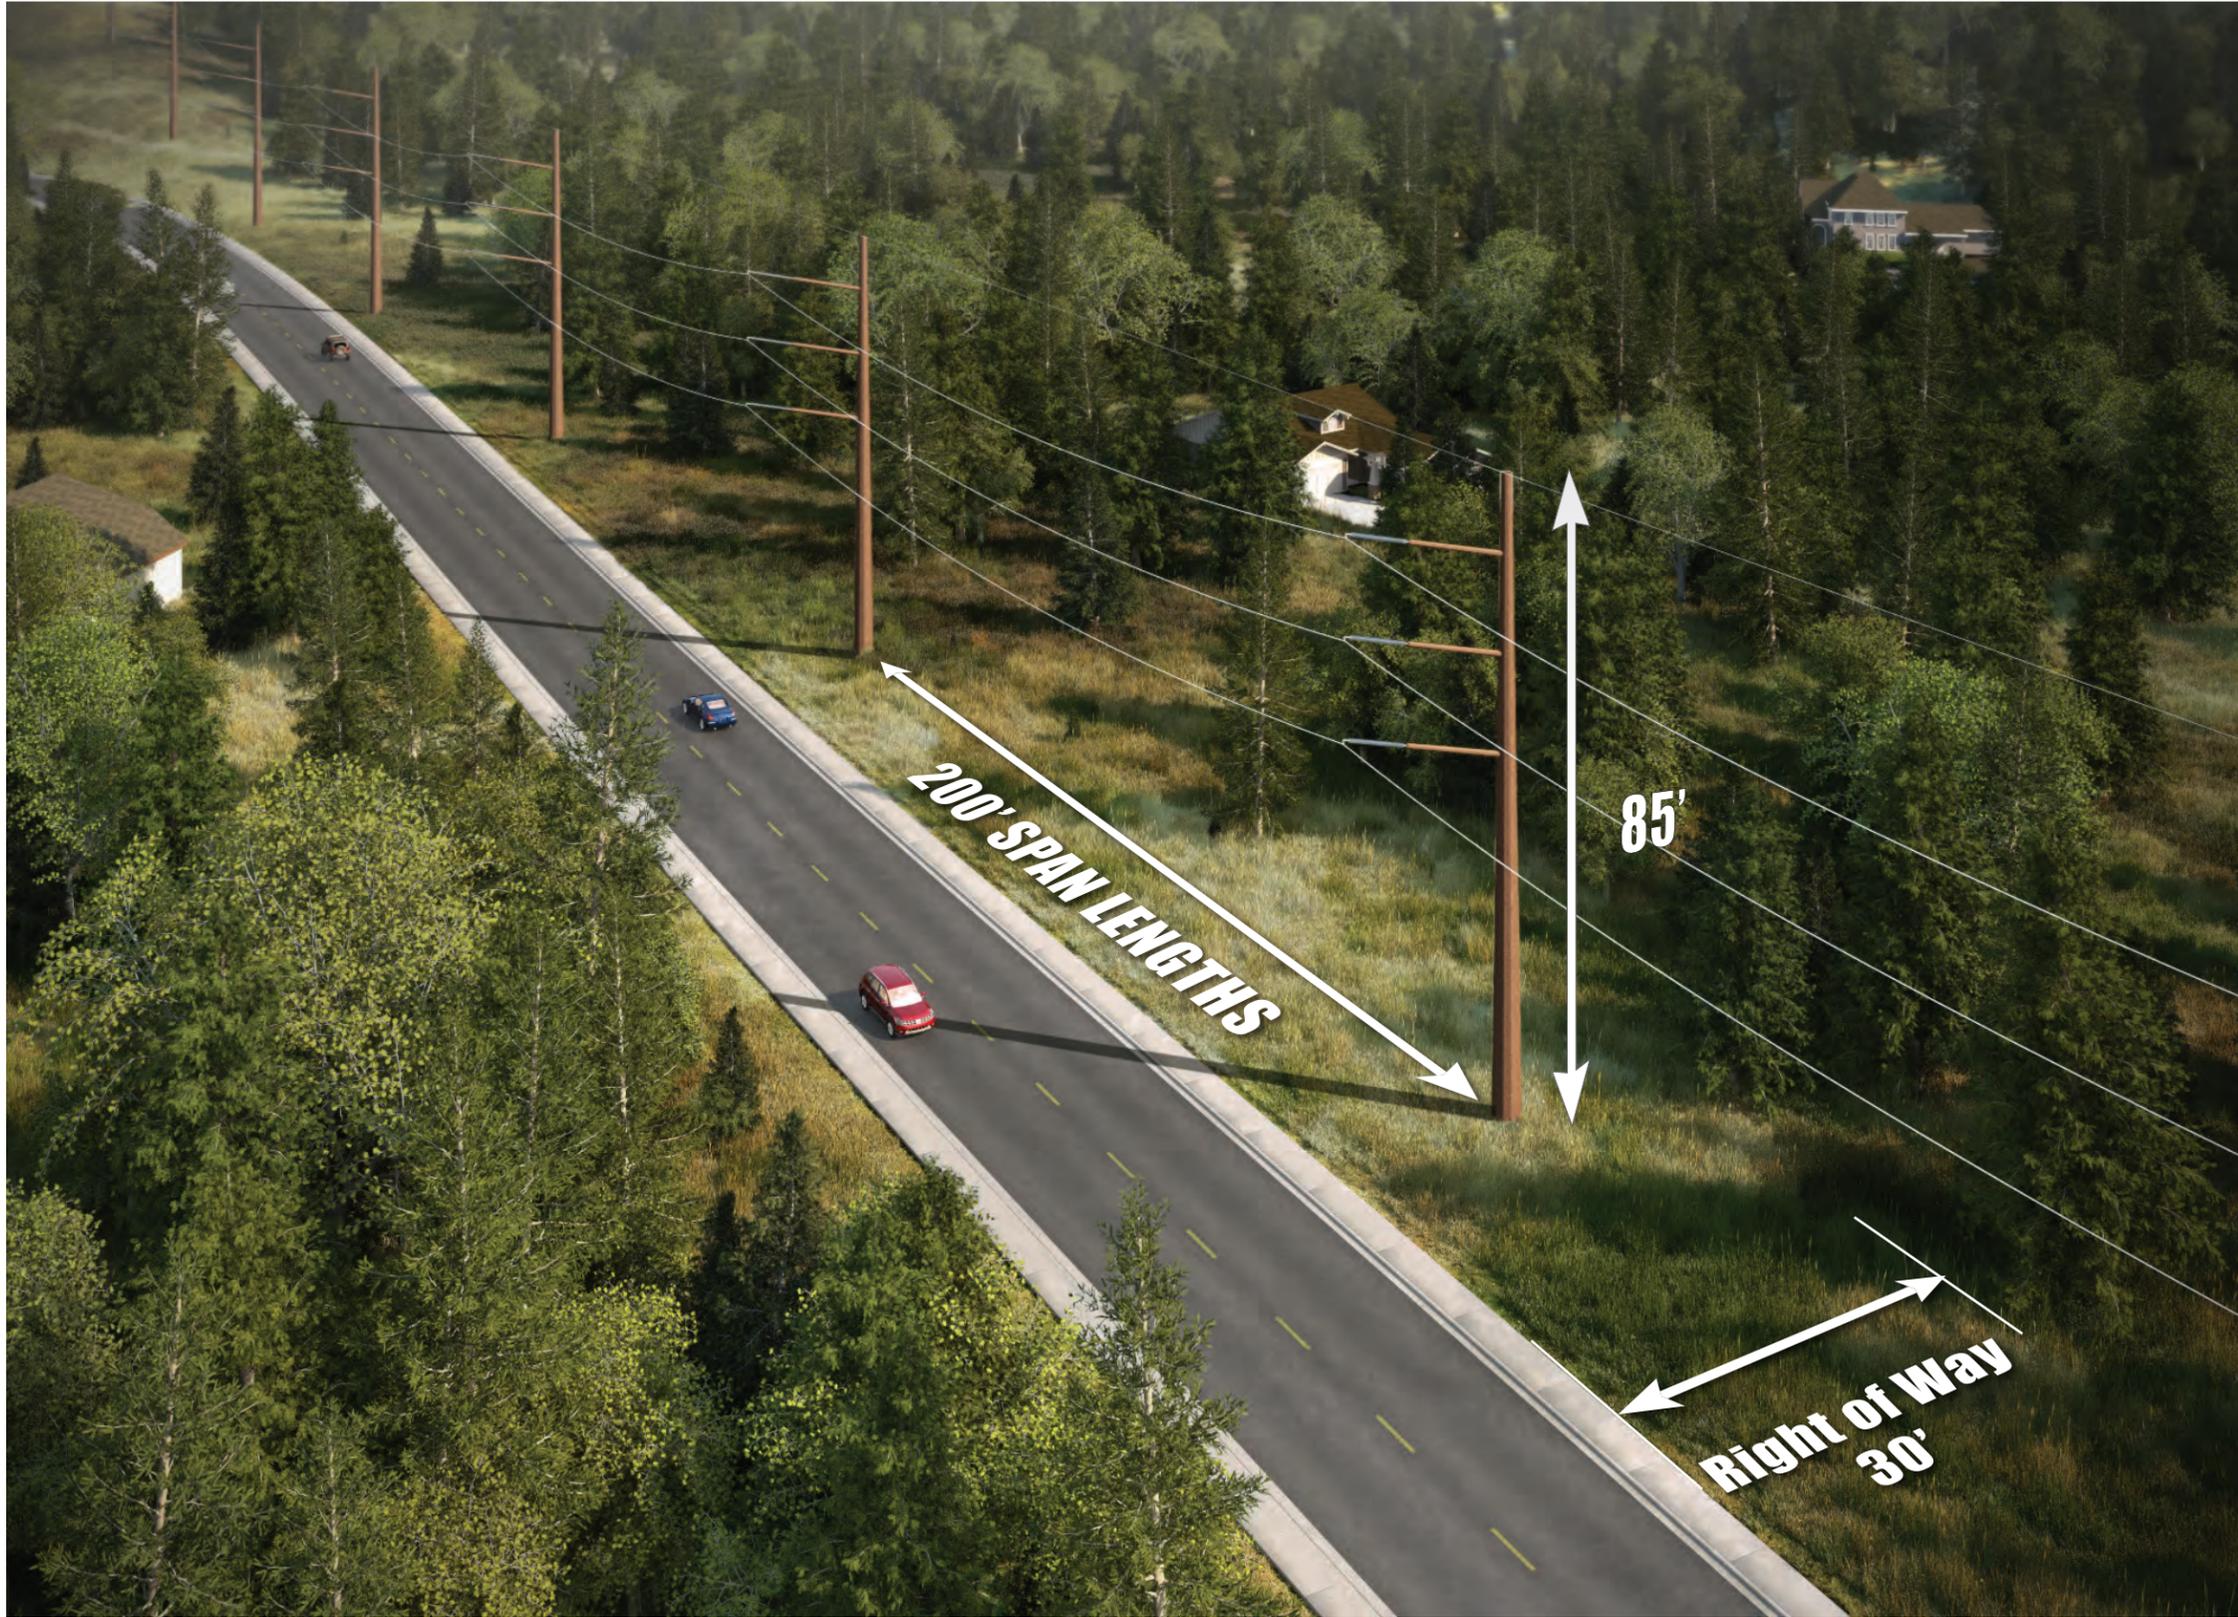
POLE TYPE G3-2

- Height: 85'
- Right of Way: 30'
- Span Lengths: 200'

Note: Span lengths and heights shown are typical and may vary due to localized site conditions and engineering requirements.

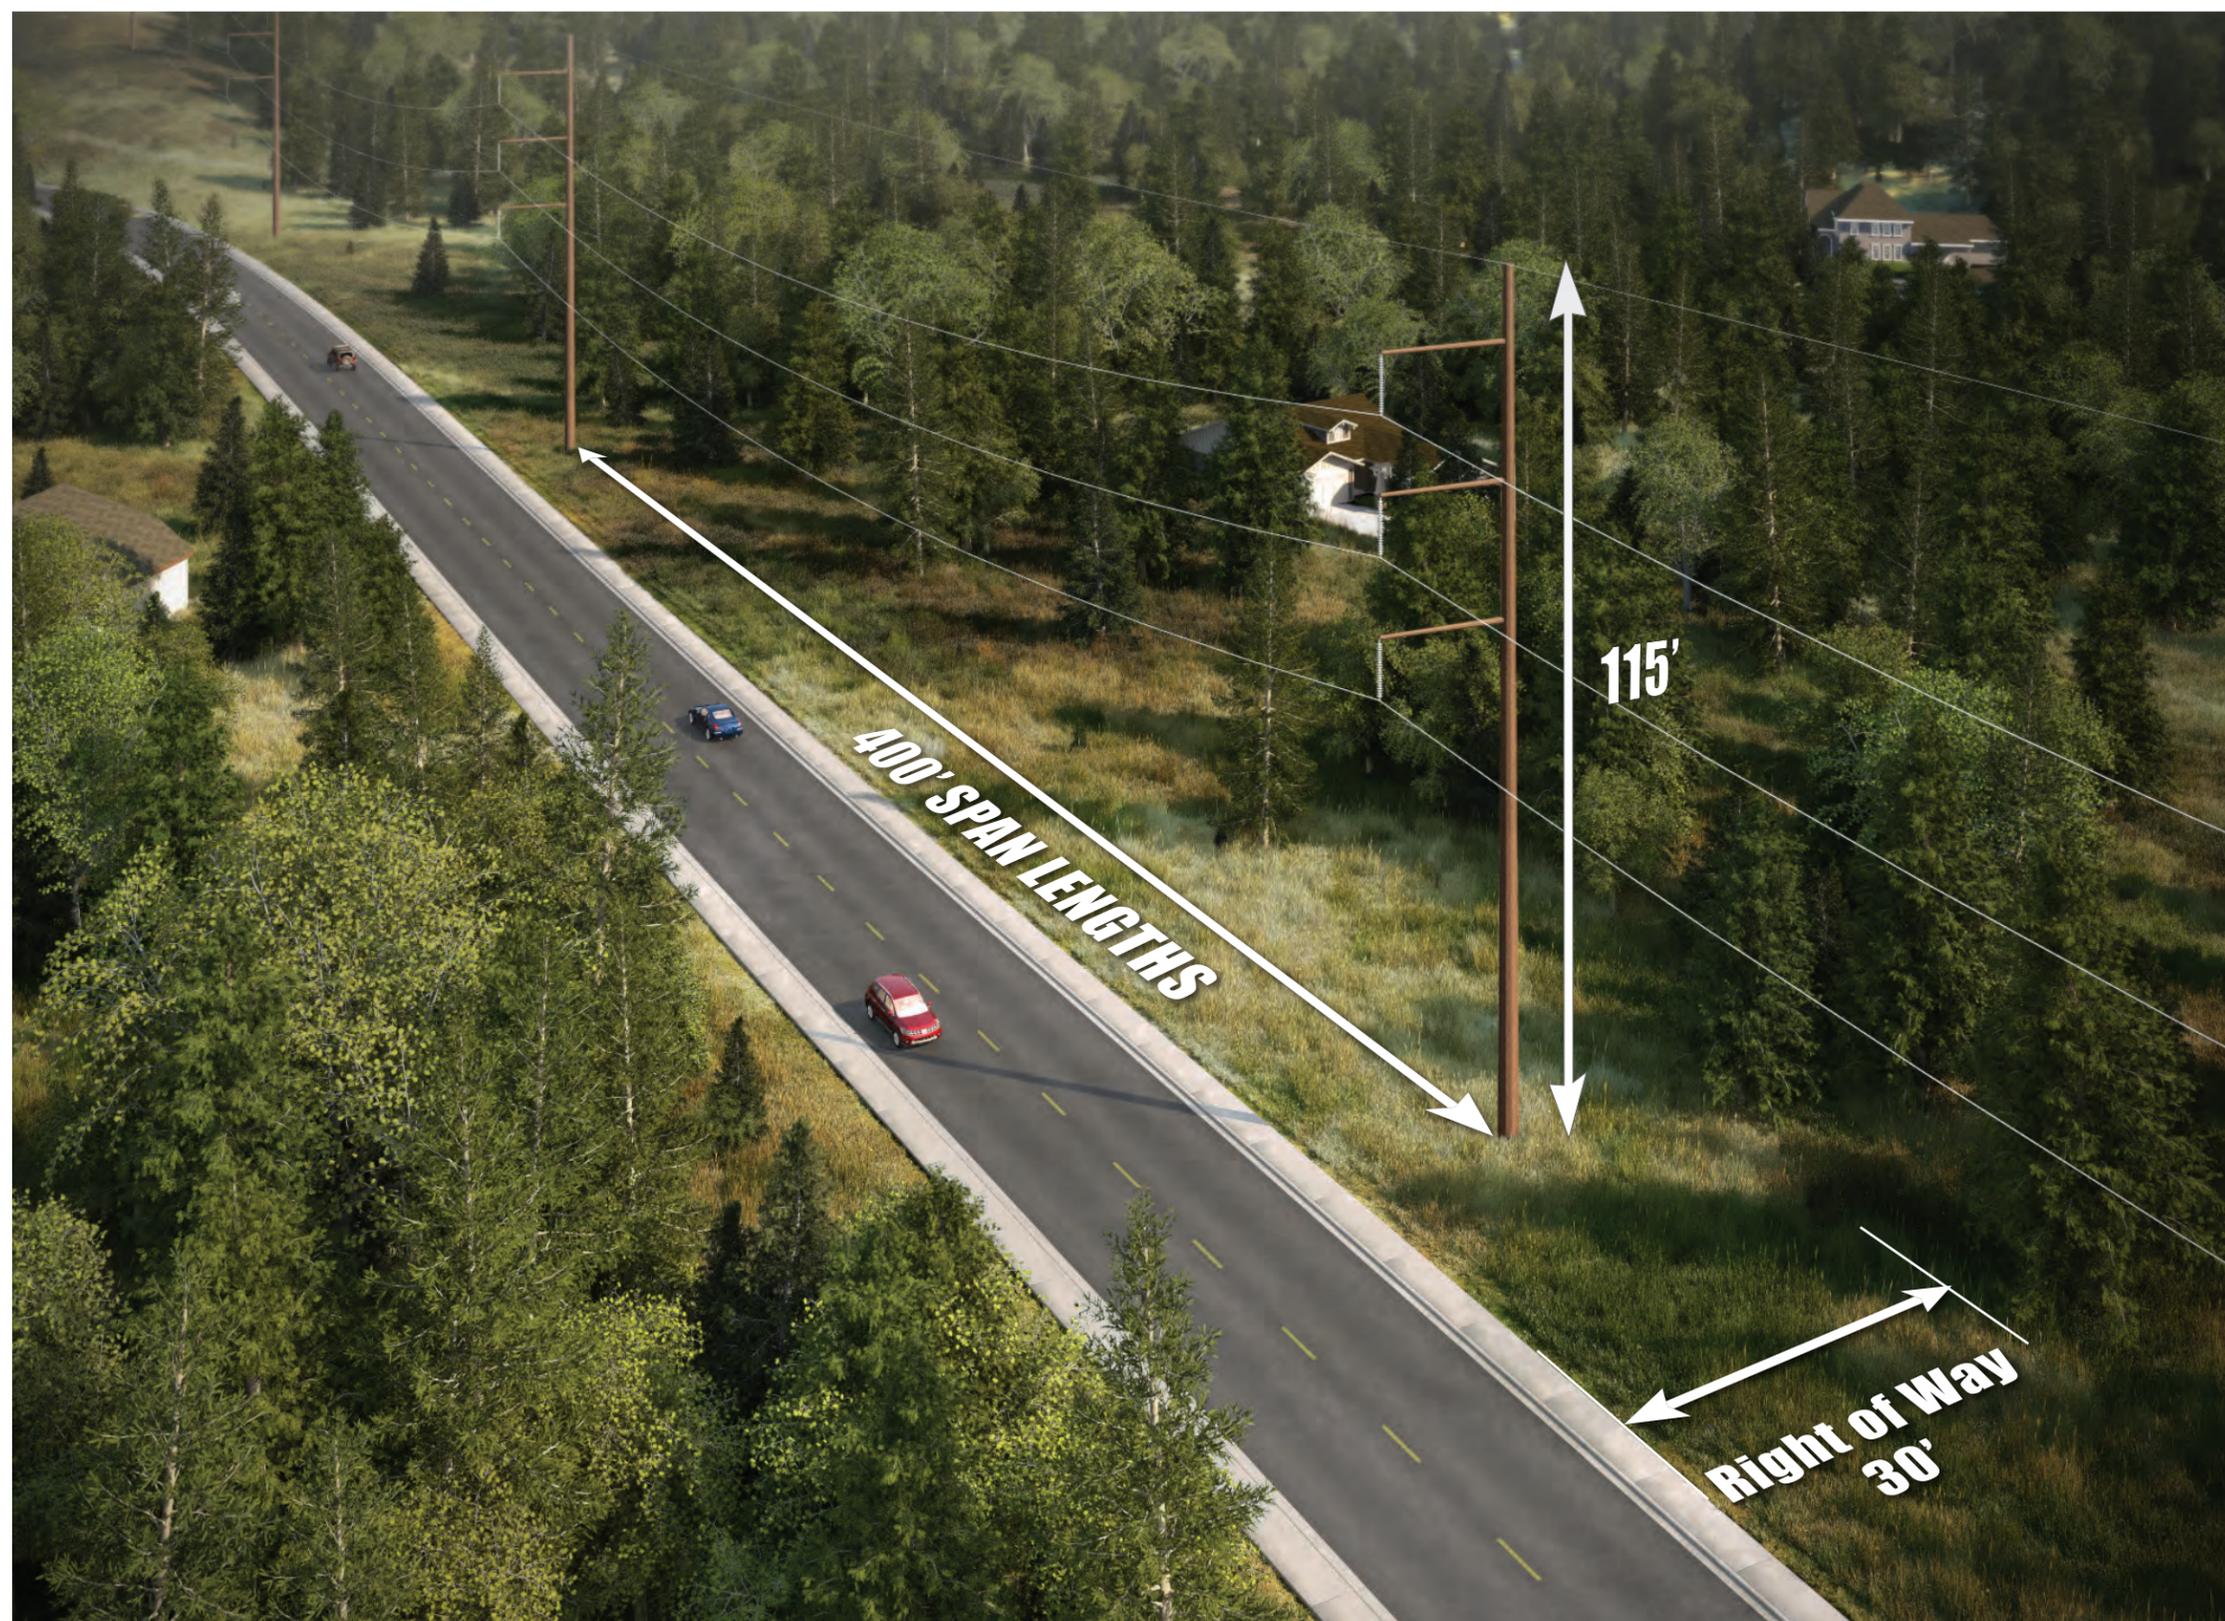
POLE TYPE G3-4

- Height: 115'
- Right of Way: 30'
- Span Lengths: 400'

Note: Span lengths and heights shown are typical and may vary due to localized site conditions and engineering requirements.

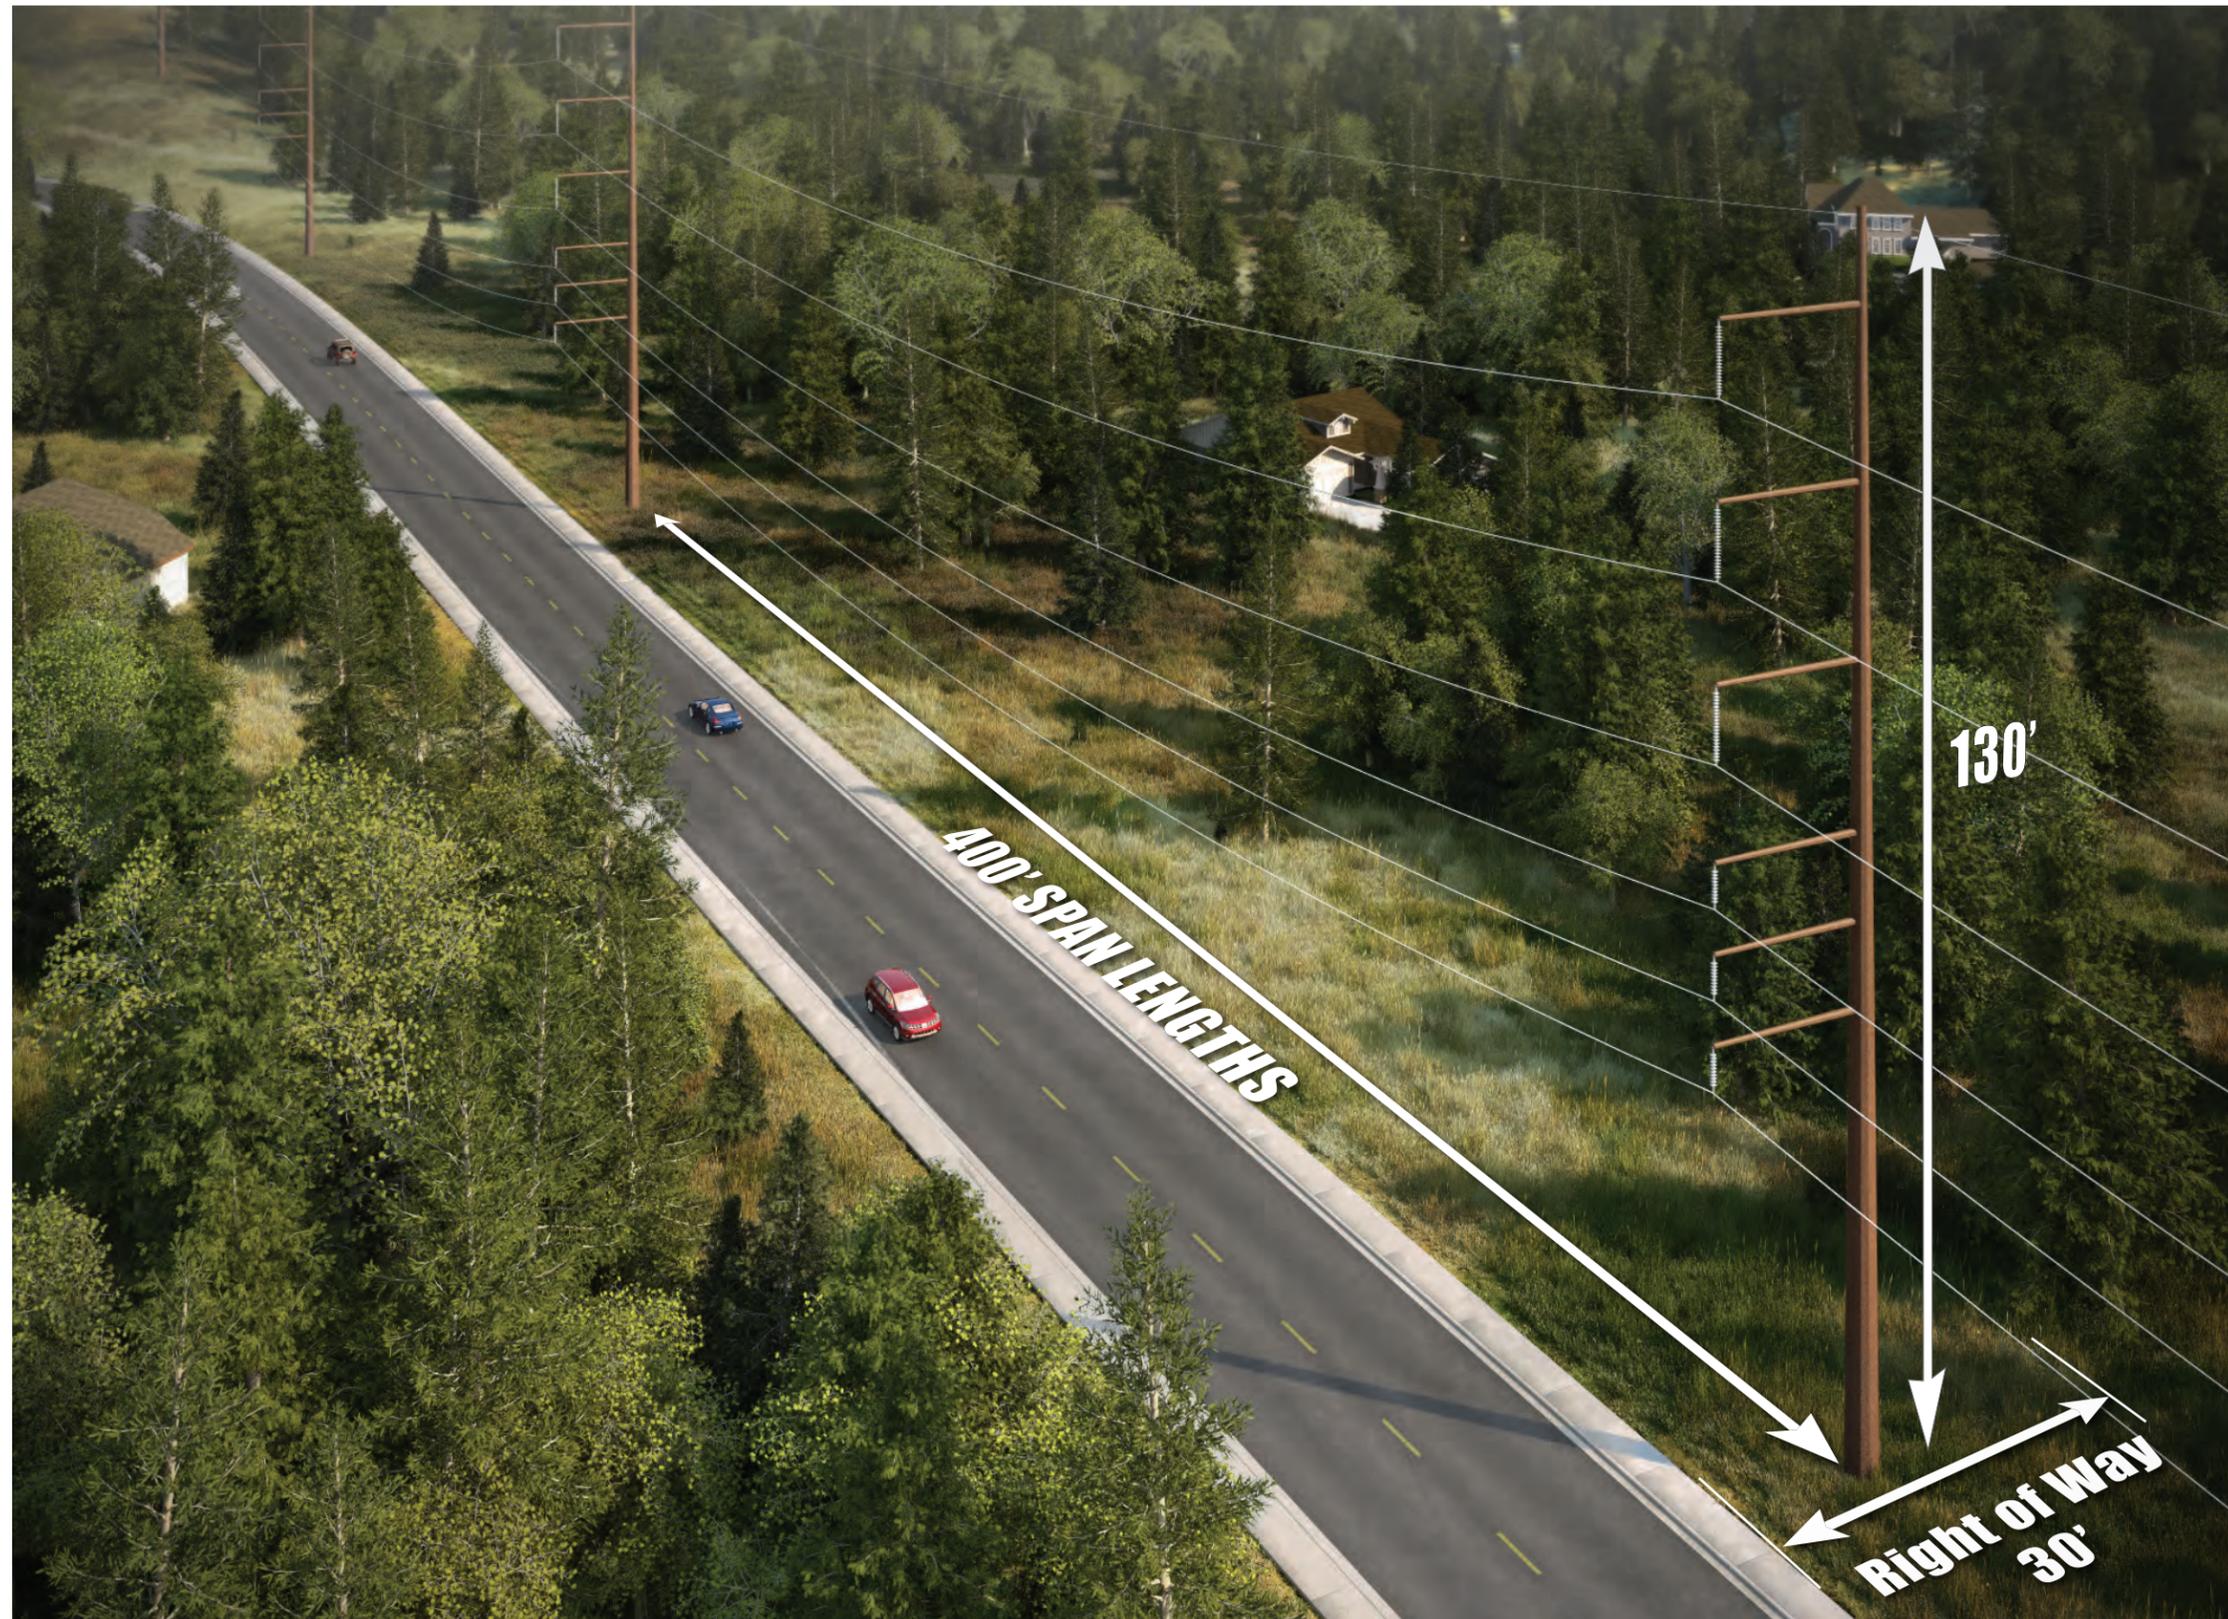
POLE TYPE G3-8

- Height: 130'
- Right of Way: 30'
- Span Lengths: 400'

Note: Span lengths and heights shown are typical and may vary due to localized site conditions and engineering requirements.

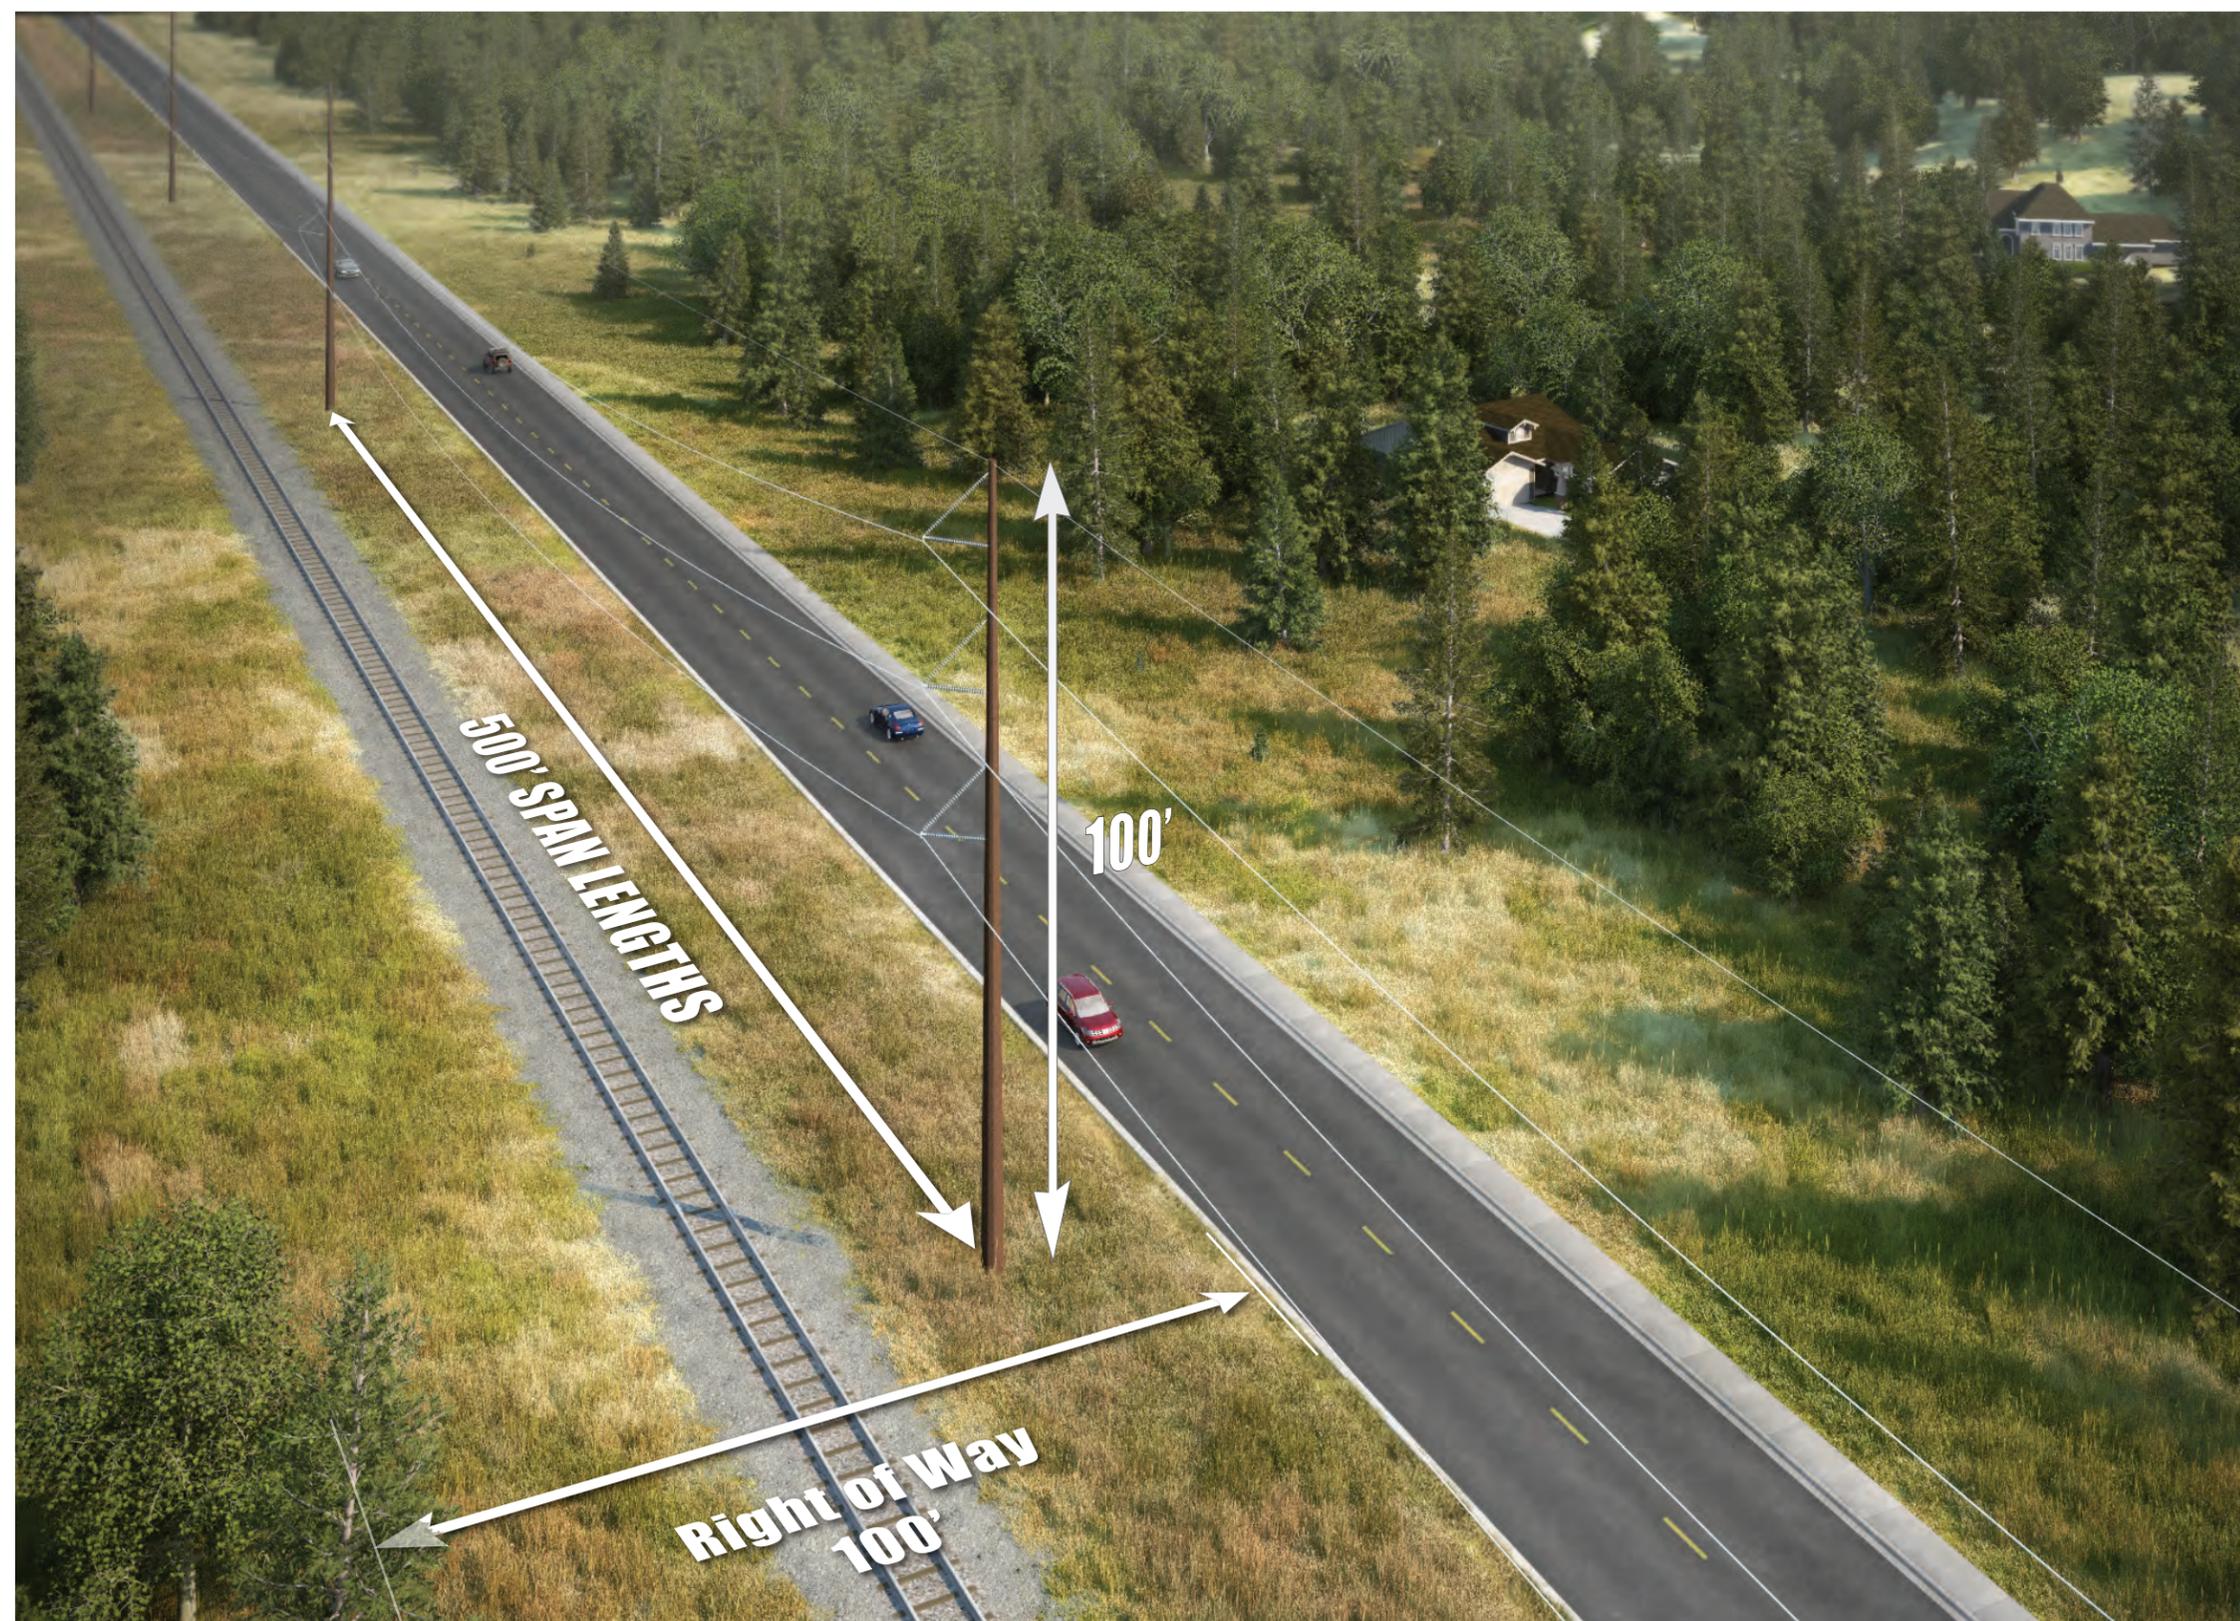
POLE TYPE G4-5

- Height: 100'
- Right of Way: 100'
- Span Lengths: 500'

Note: Span lengths and heights shown are typical and may vary due to localized site conditions and engineering requirements.
